# **T2K Beam Window Replacement Work**

**2017.9.19  
KEK IPNS  
Tada**

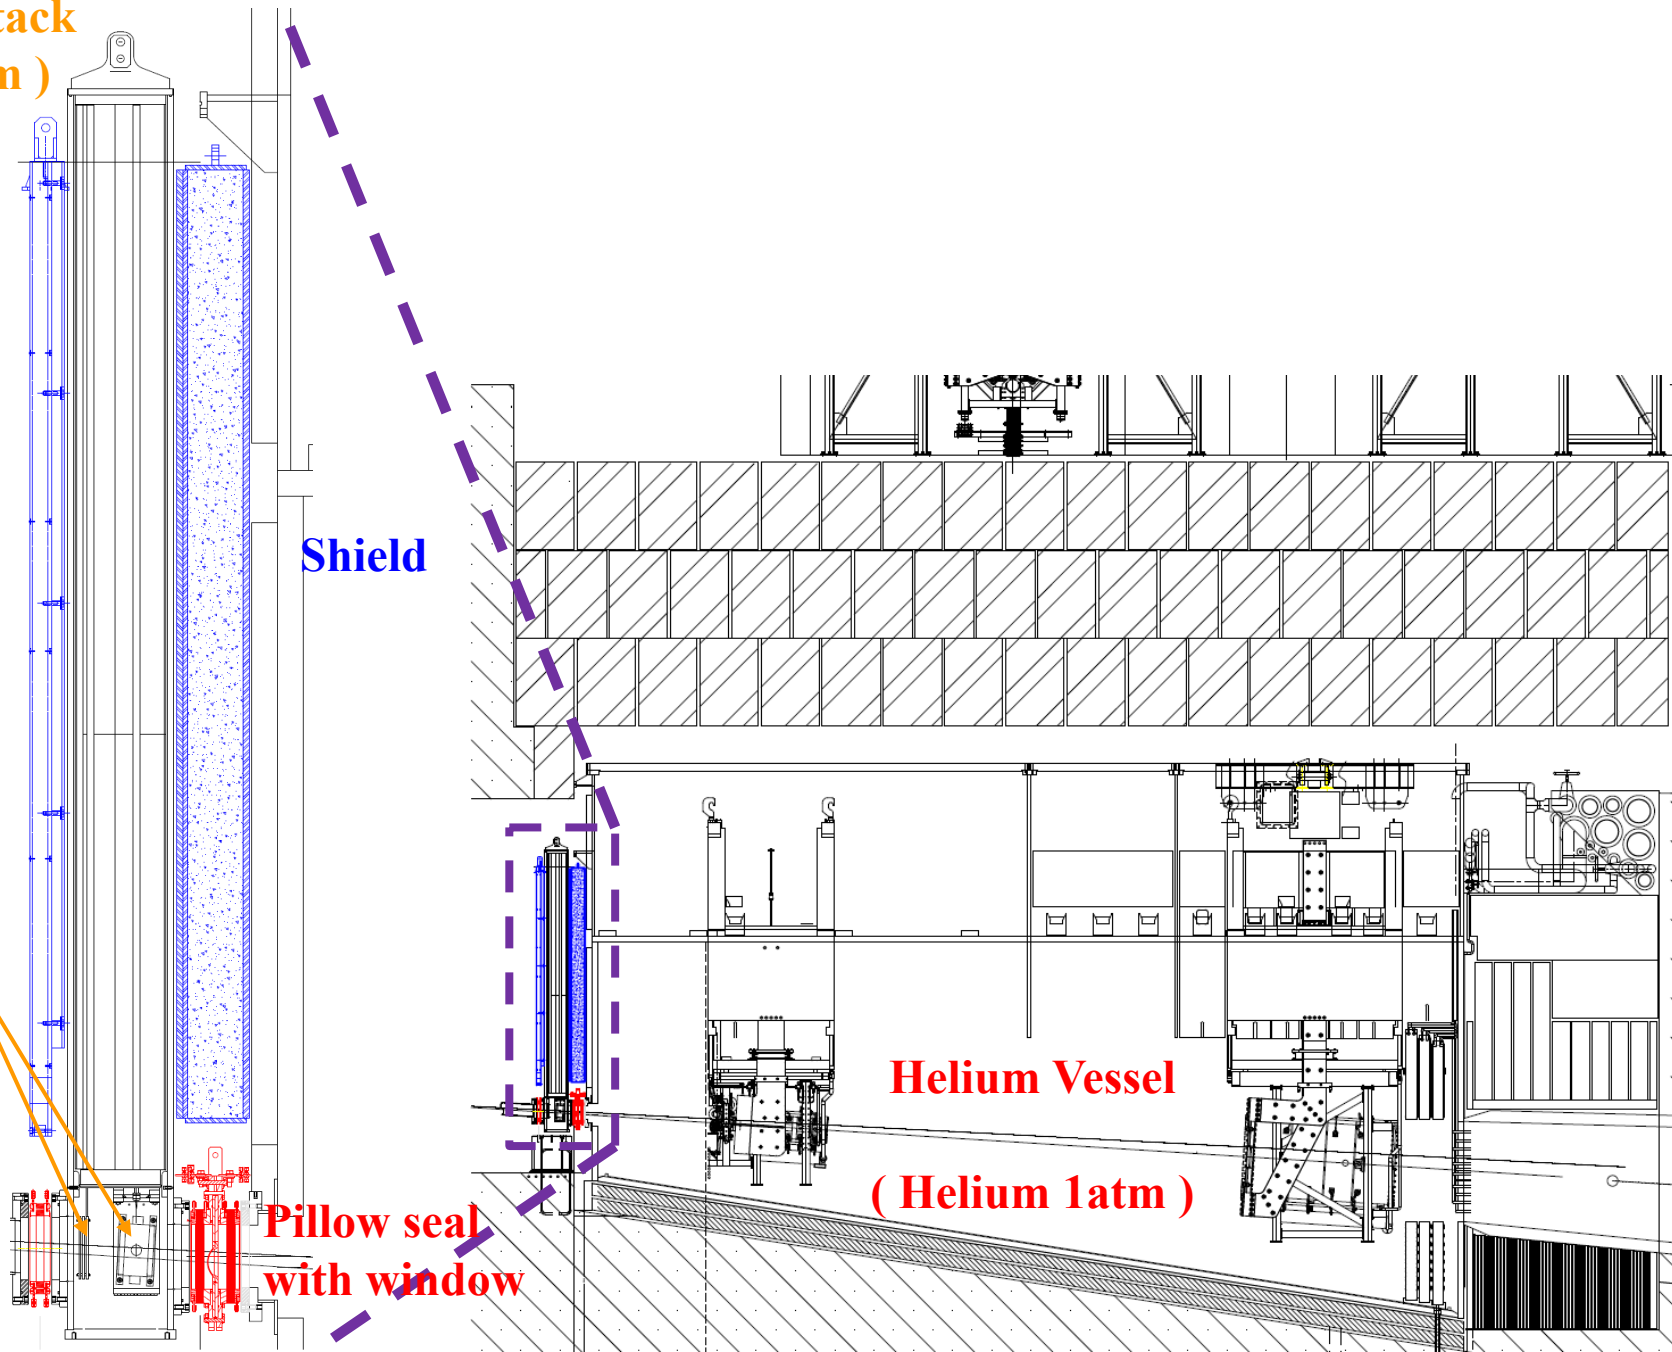
**Monitor Stack  
( in vacuum )**

**Beam  
Monitor**

**Pillow seal  
without  
window**

**Pillow seal  
with window**

**Helium Vessel  
( Helium 1atm )**

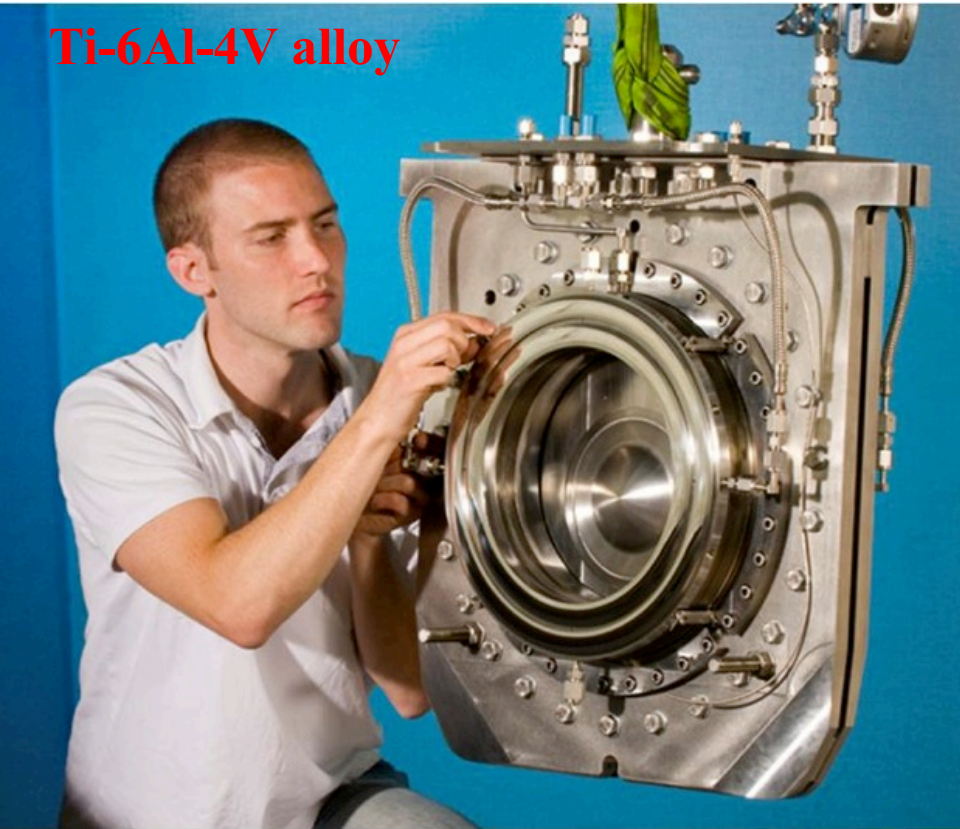
# Motivation for replacement work

**Ti-6Al-4V alloy**

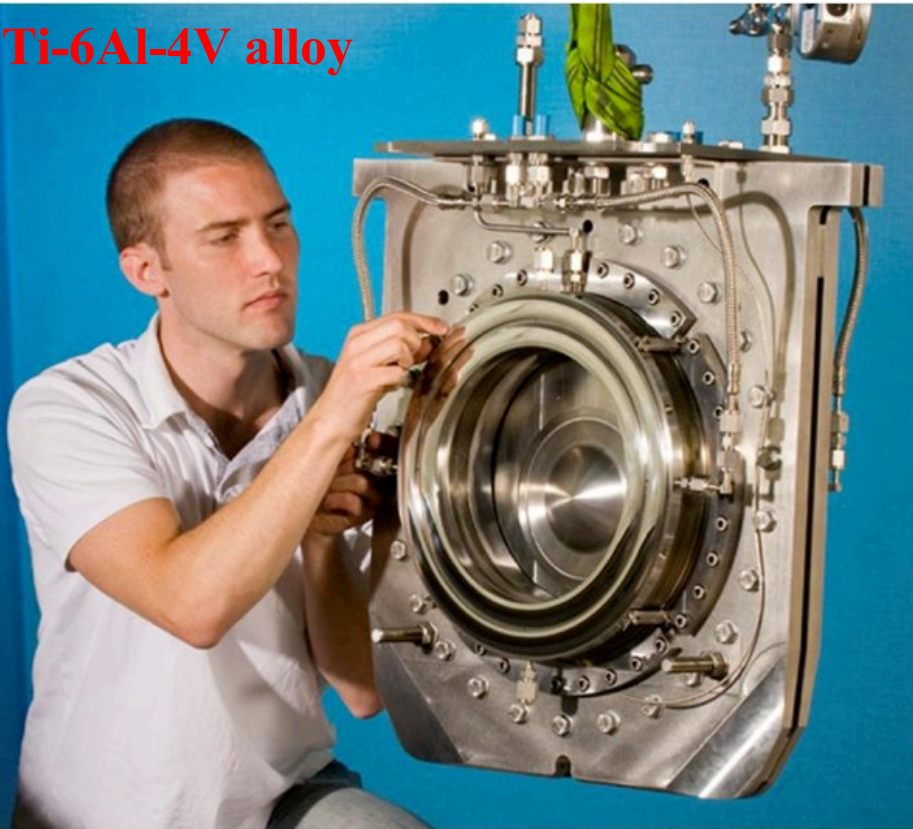
# Motivation for replacement work

**Ti-6Al-4V alloy**

We have used the present beam window all the time since the T2K experiment started.

The present beam window have been exposed to  $2.2 \times 10^{21}$  protons.

**-> 1.8 DPA!!**

This value easily exceeds the reach of the data we have, so we can't guarantee safety of the beam window.

**When the beam window rips, there is a possibility that the splinters of the window are scattered into the primary beam line and cause serious pollution.**

**→ We decided to replace the beam window before it breaks.**

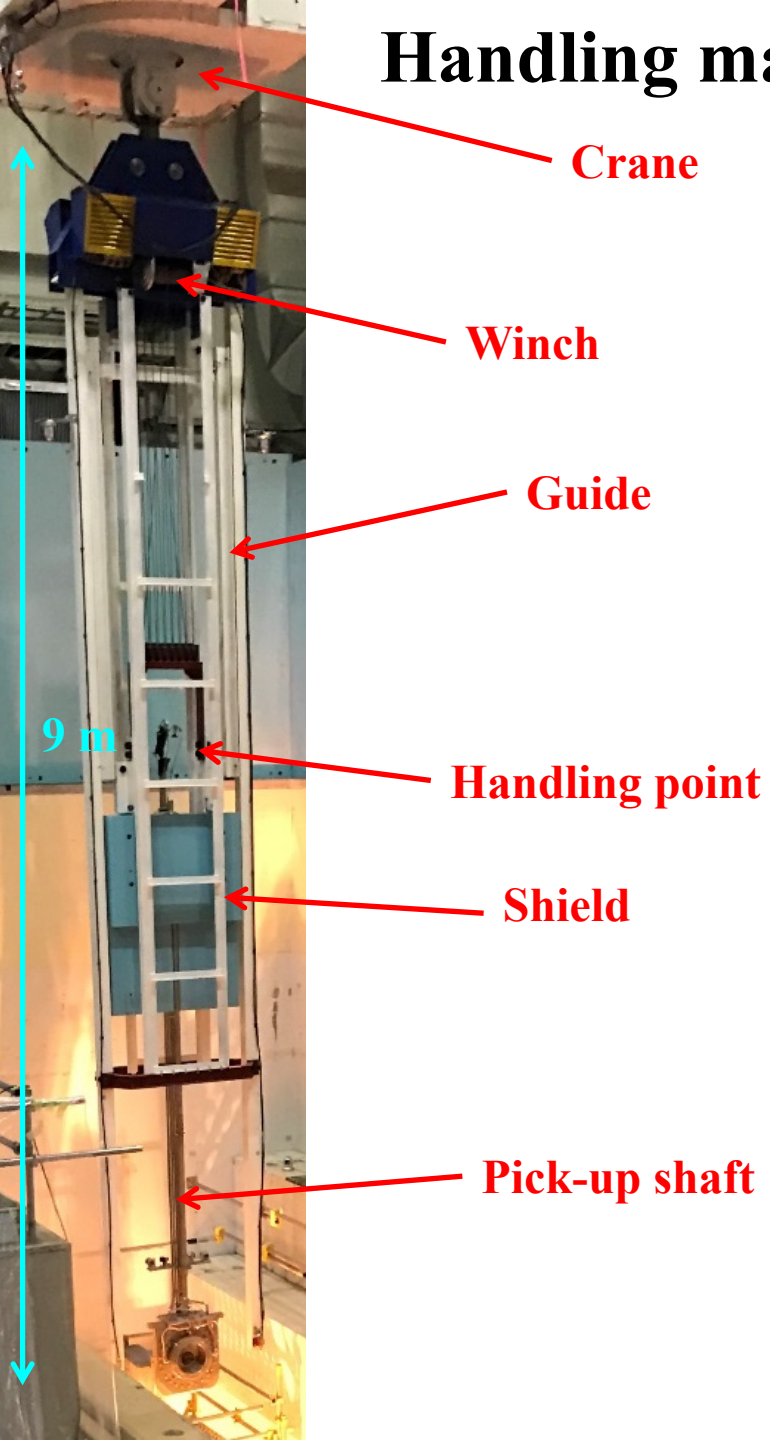
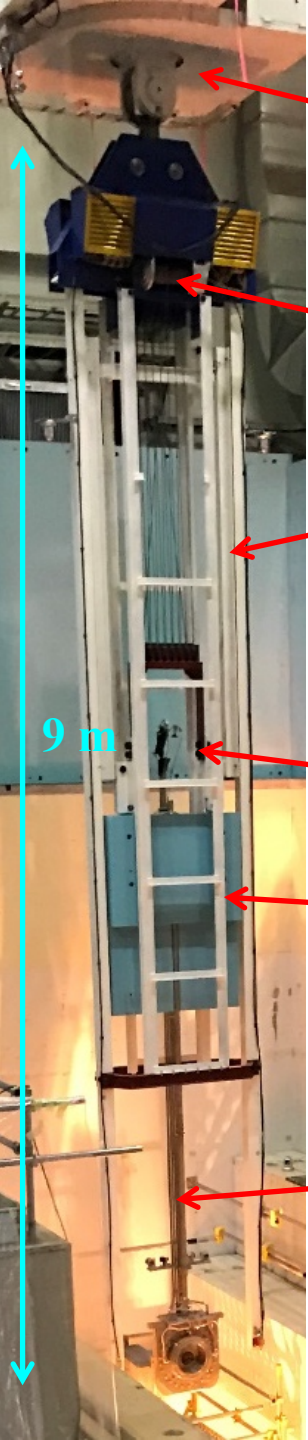
The handling machine is attached to crane, and it moves by crane horizontally.

In vertical direction, it move by crane before the guide touch down the guide on the service-pit side, and it move by winch built in the handling machine after touch down.

**Handling point**

**Pick-up shaft**

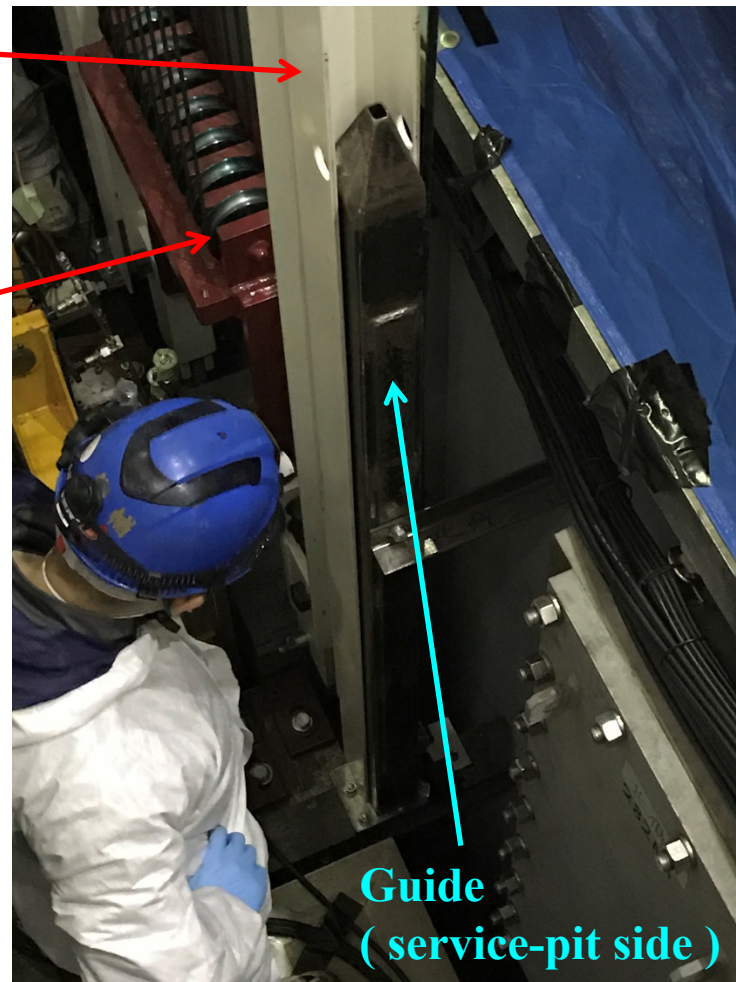
The guide of handling machine fits the guide on the service-pit side or the maintenance side by outside.

And the handling point moves along inside of the guide by the winch.

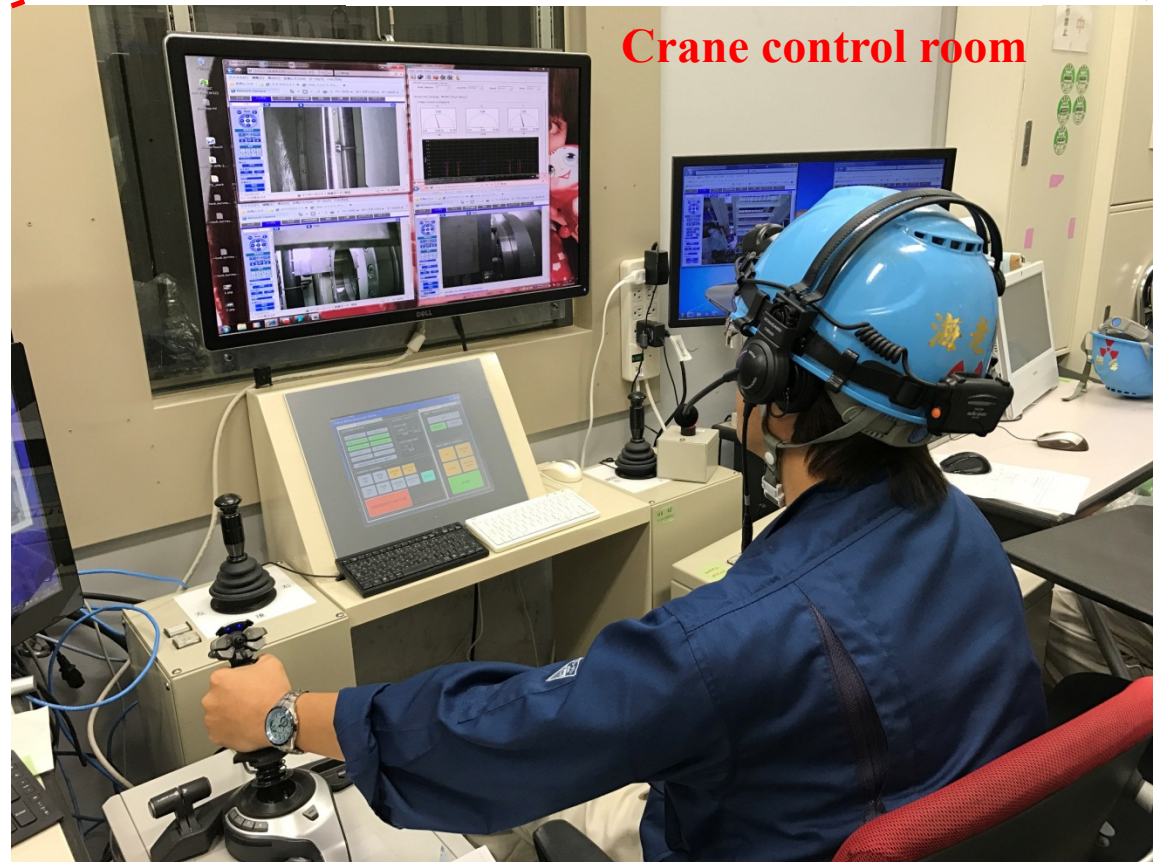
# Handling machine for beam window

**The handling machine is attached to crane, and it moves by crane horizontally.**

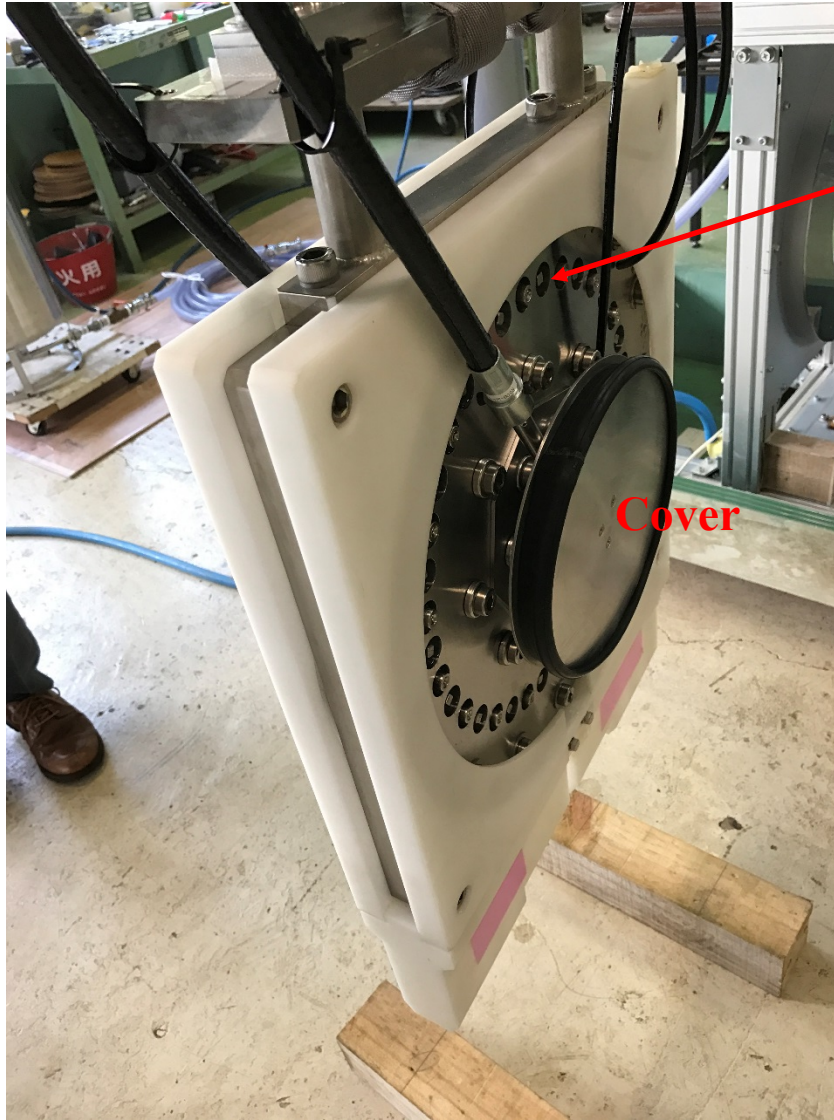
It is the most important for the replacement work to keep clean the mirror flange of the pillow seal, so we developed the cleaner for the mirror flange. We use the cleaner when the mirror flanges are dirty.

**Nozzles :**  
**Air or alcohol is sprayed here**

**Cover**

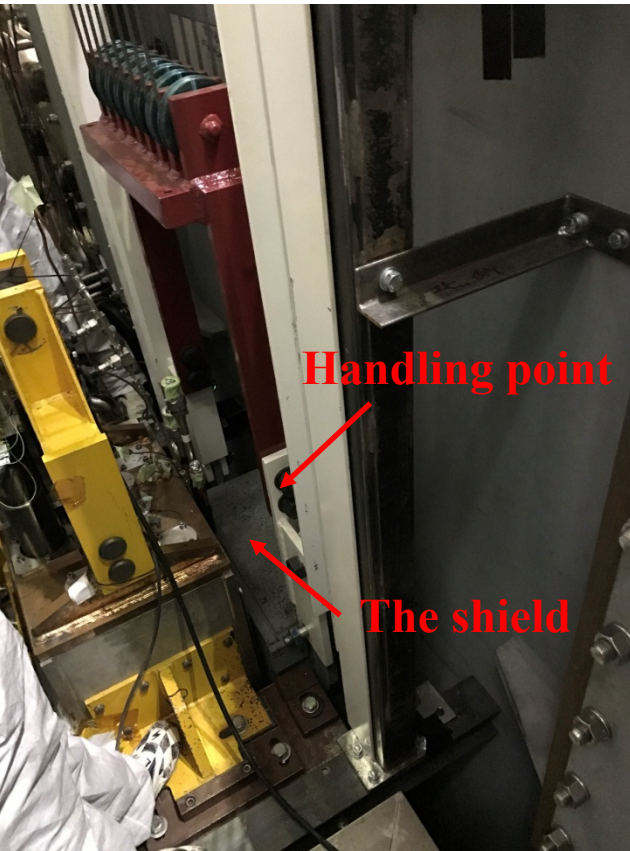
Pull the shield out with the handling machine **by remote**

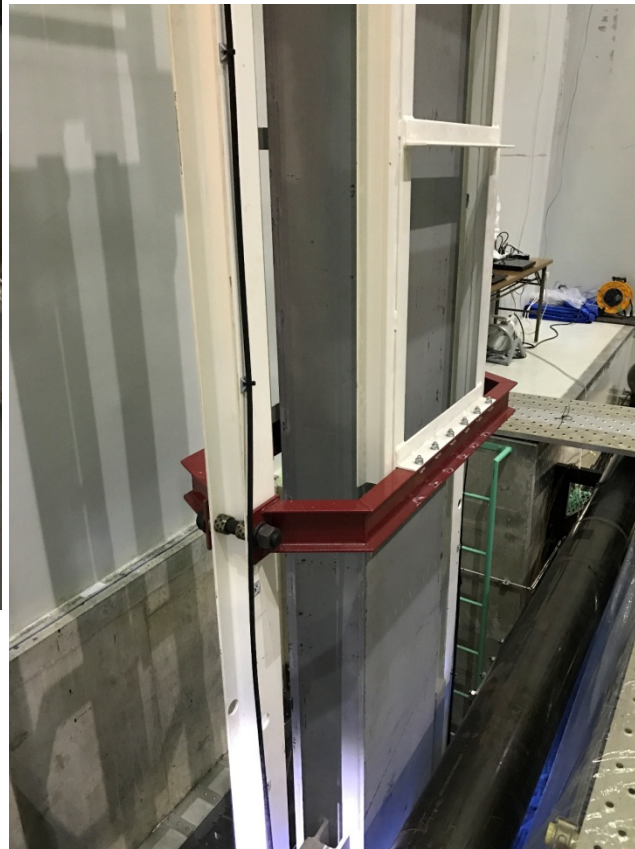
Remove the shield to the maintenance area with the handling machine **by remote**

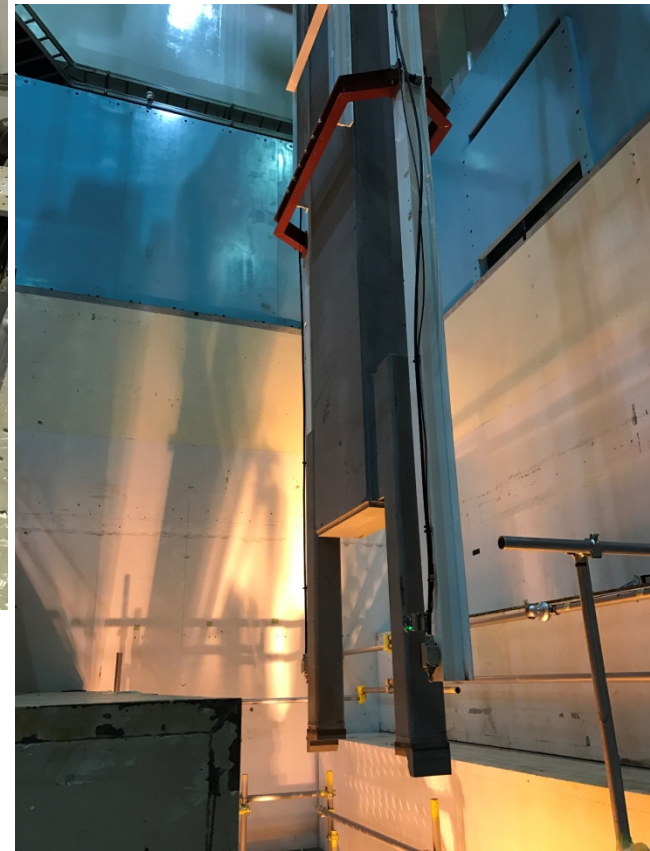
Connect the top of the shield above the beam window to the handling point of the handling machine **by hands**

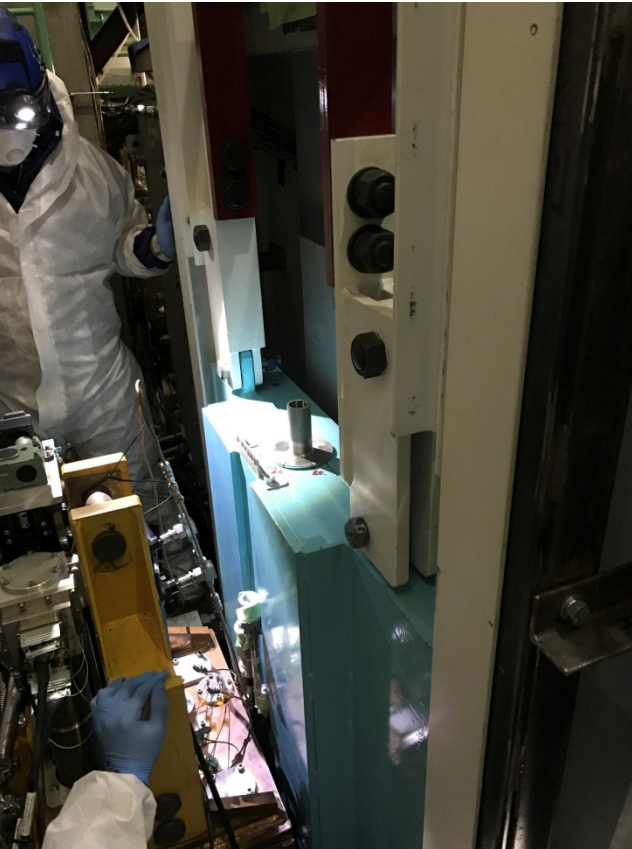
Set the handling machine  
above the beam window **by  
hand**

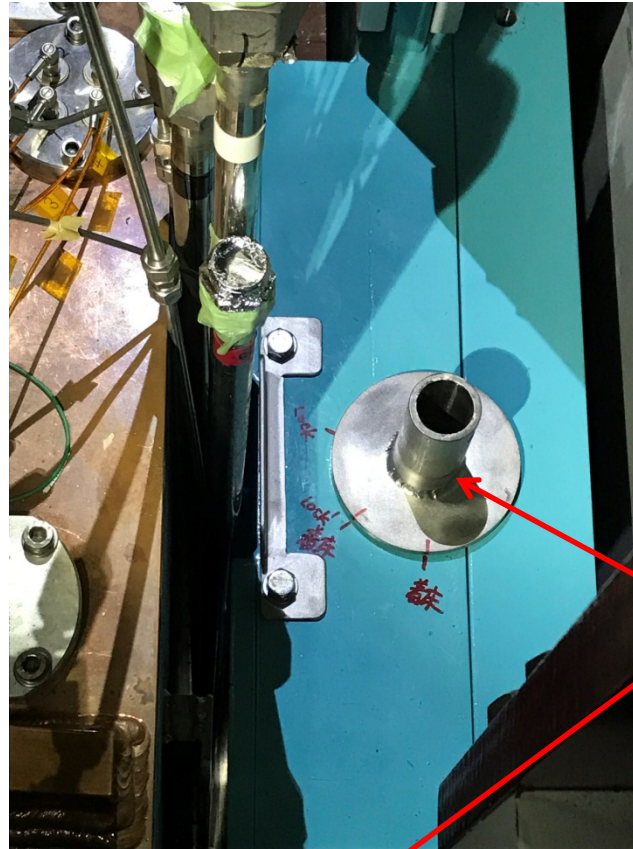
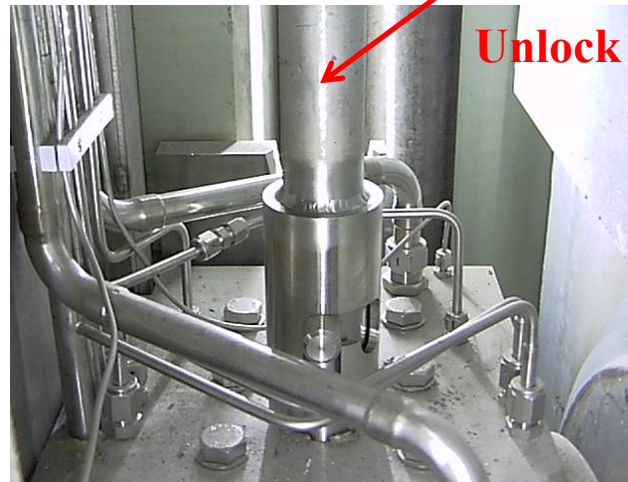
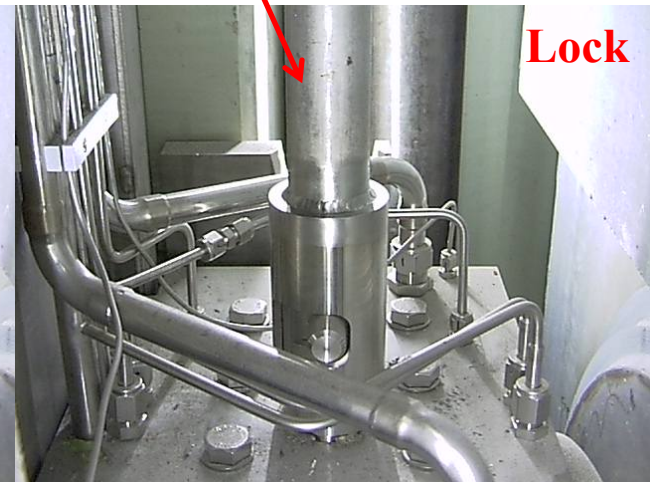
Rotate the pick-up shaft  
and lock the beam window  
**by hand** watching the top of  
the beam window ( the  
bottom of the shaft ) with  
camera

**Unlock**

**Lock**

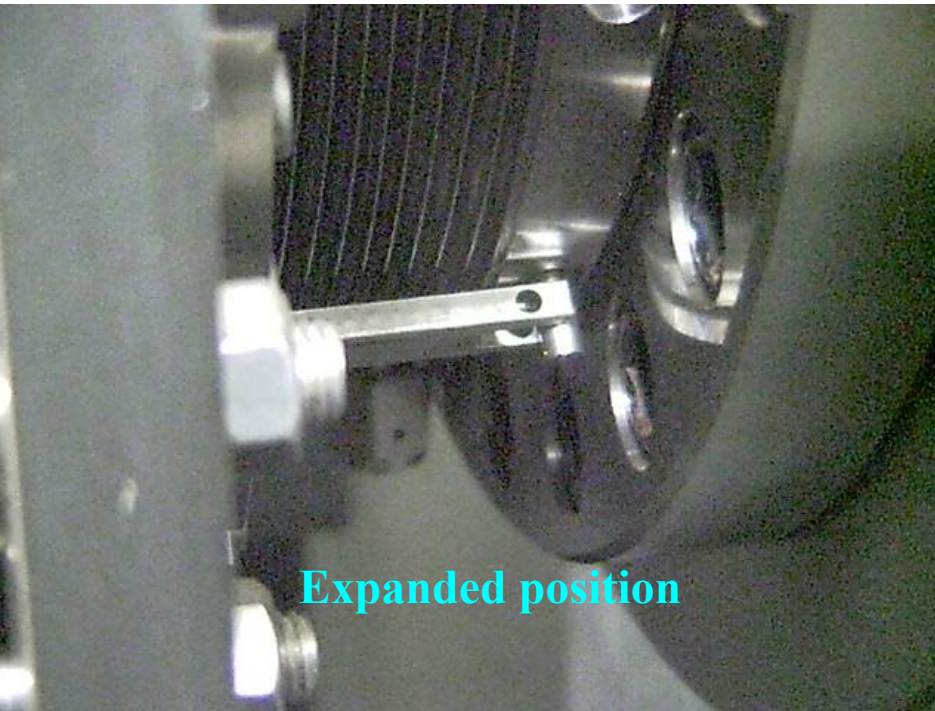
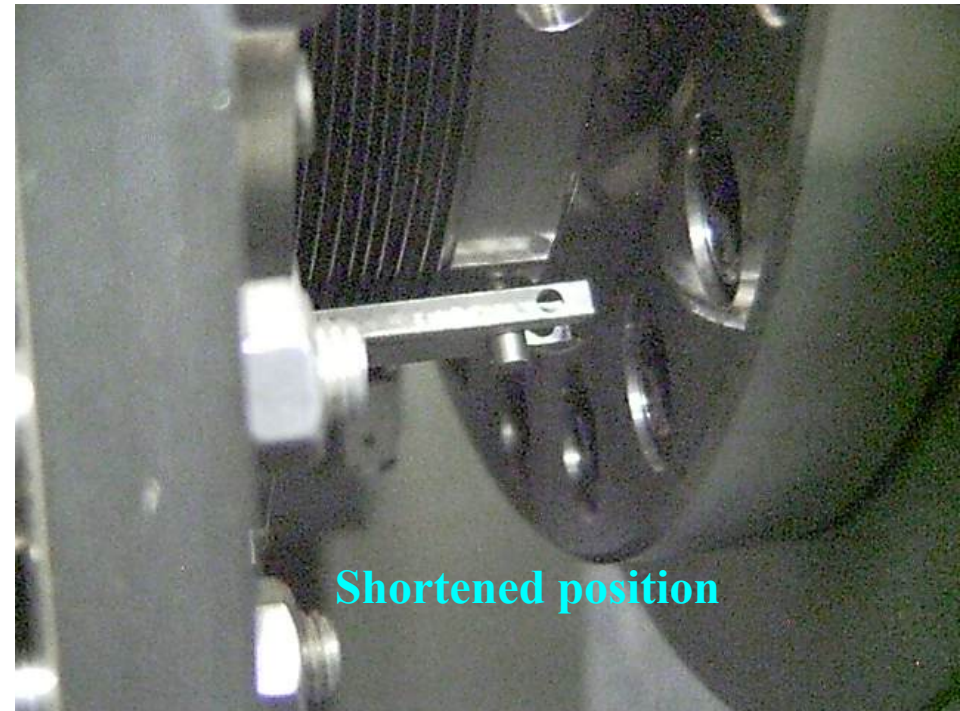
**Decrease the pressure of the pillow seal line under atmospheric pressure watching the motion of the pillows with a camera**

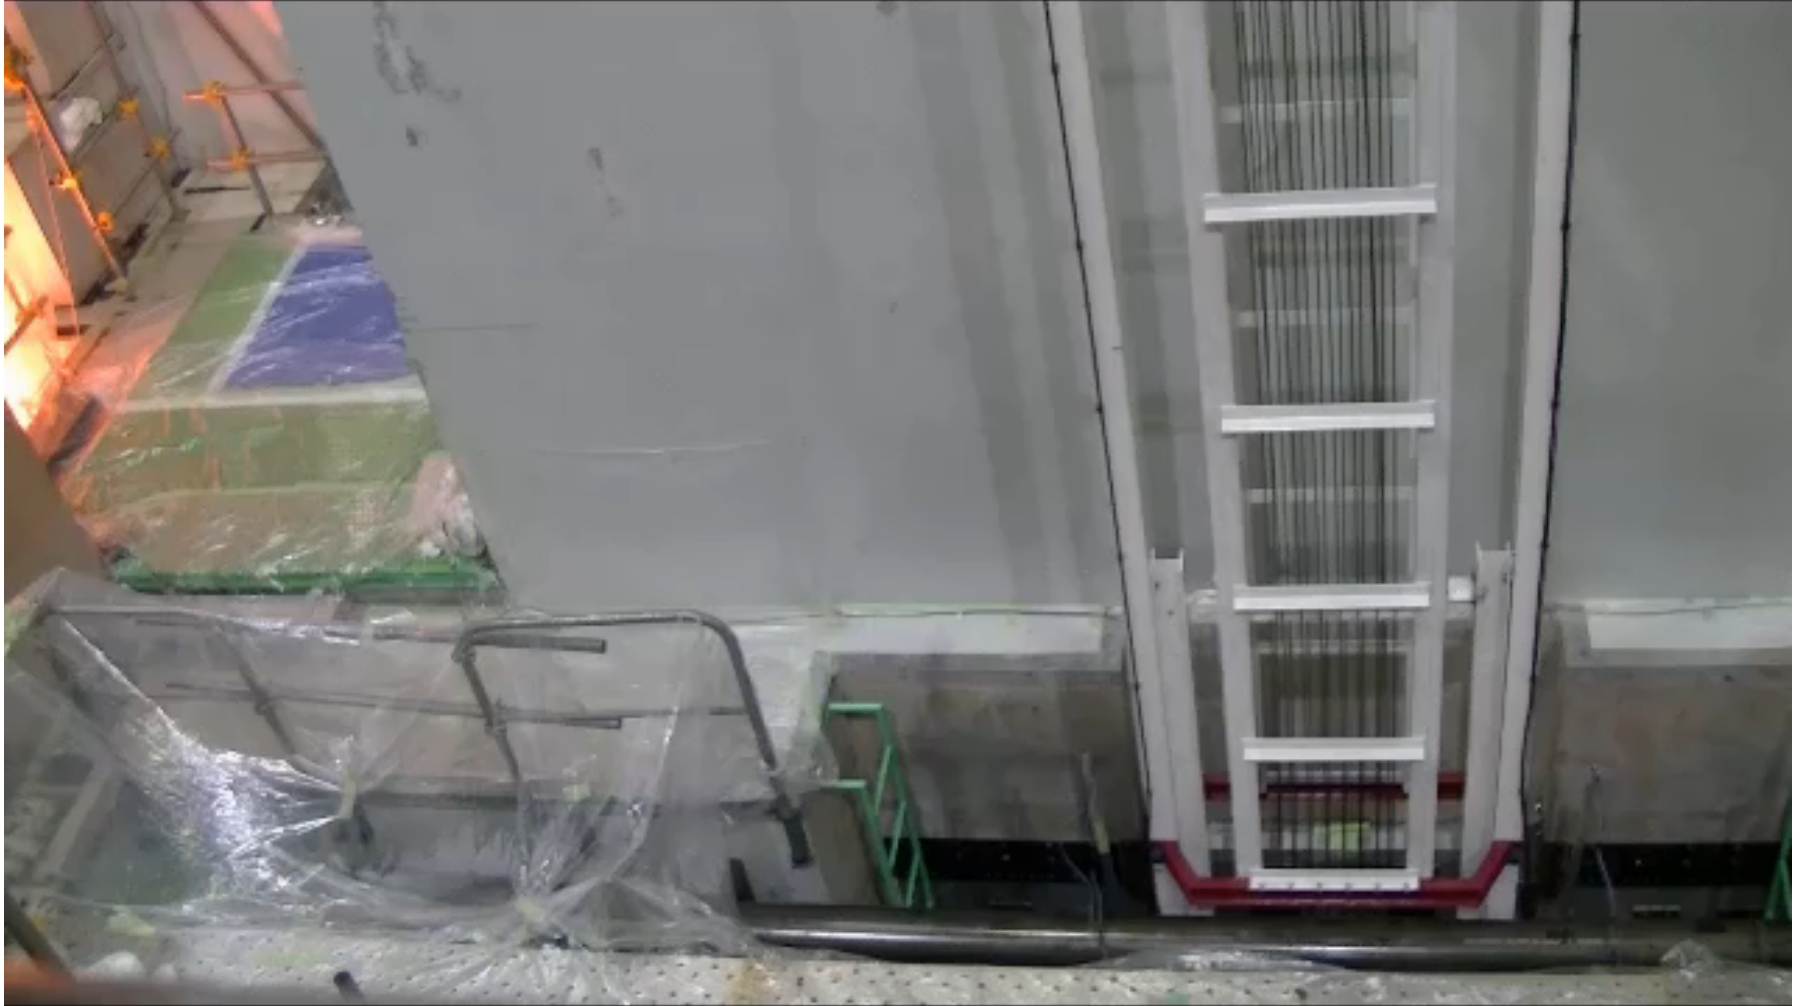
**Remove the beam window from the beam line**  
**and take it to the maintenance area Aug. 22**  
**×50 times speed**

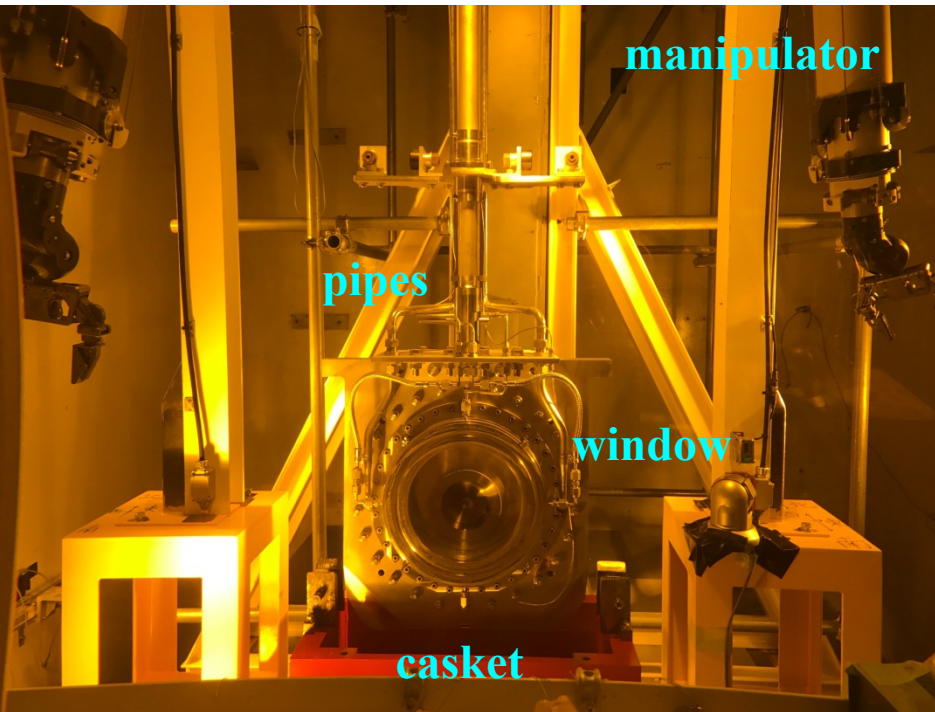
**Beam window in the maintenance area  
( through the lead glass )**

**Remove the pipes from the beam window  
with the manipulators  
( camera view )**

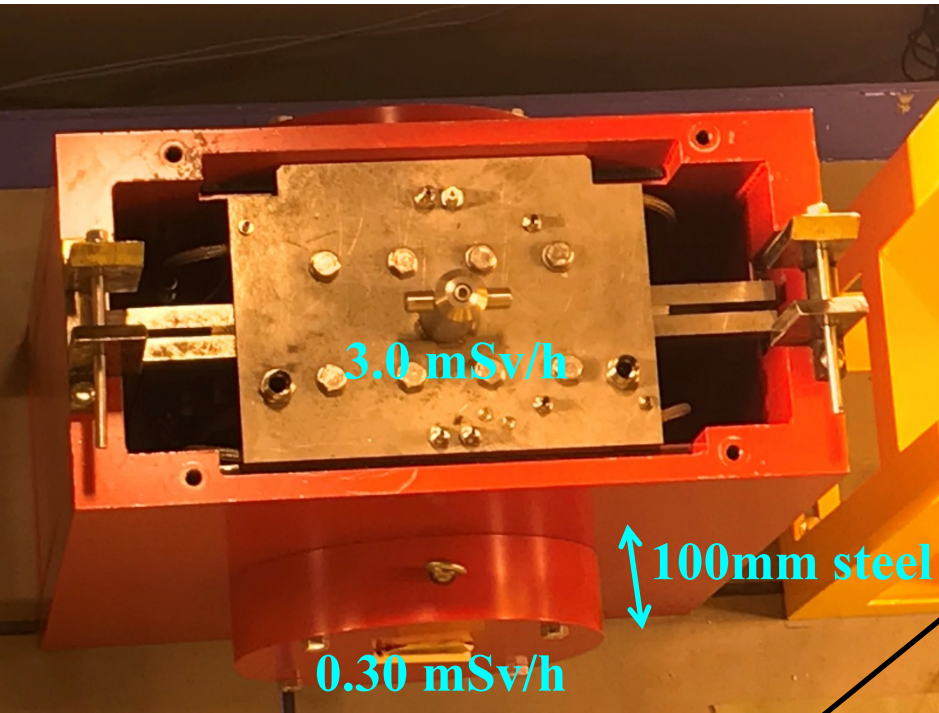
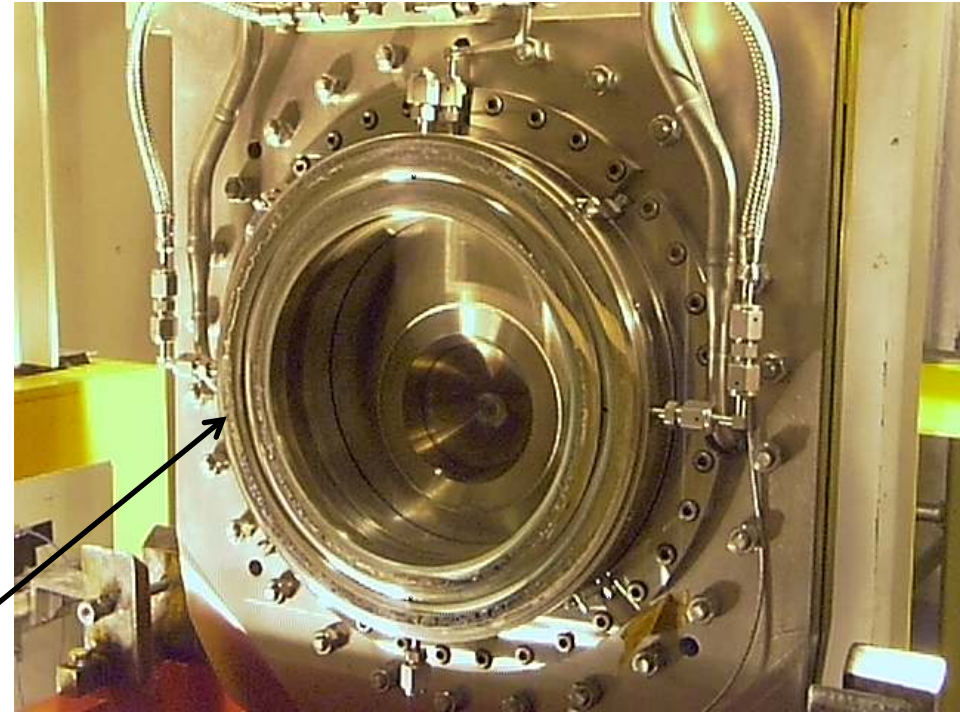
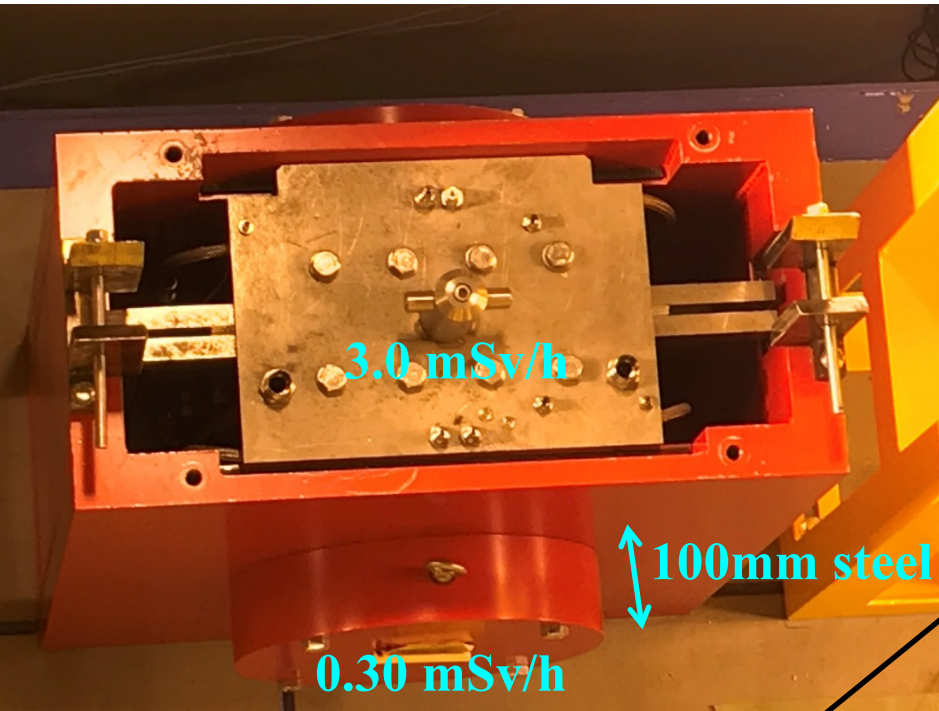
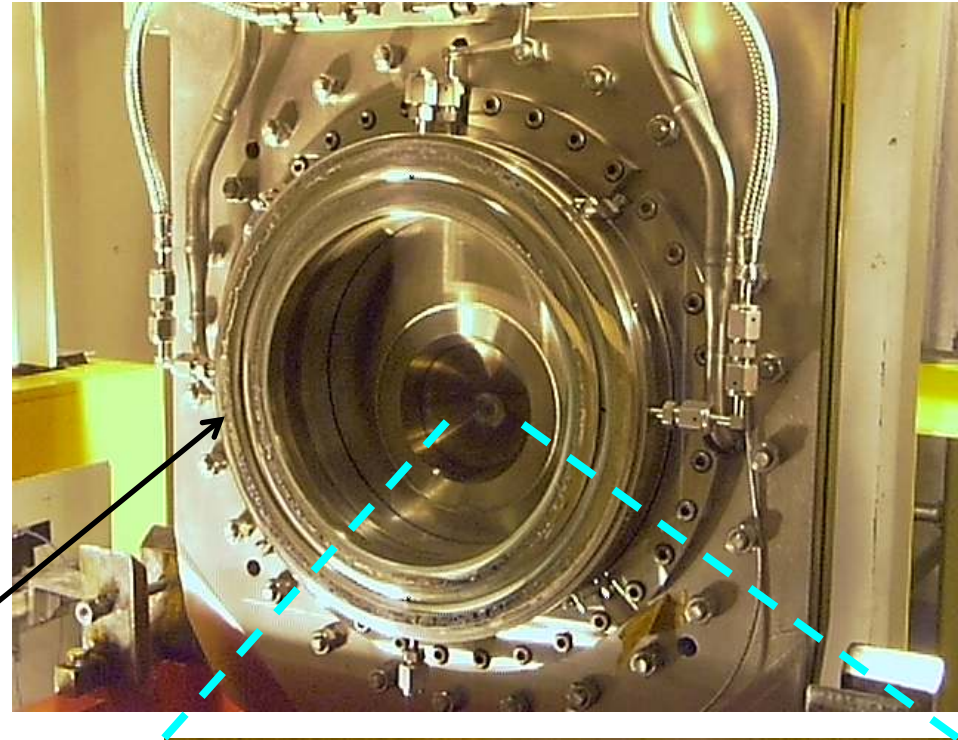
**Pillow seal is deformed, so it is impossible to reuse the old beam window.**

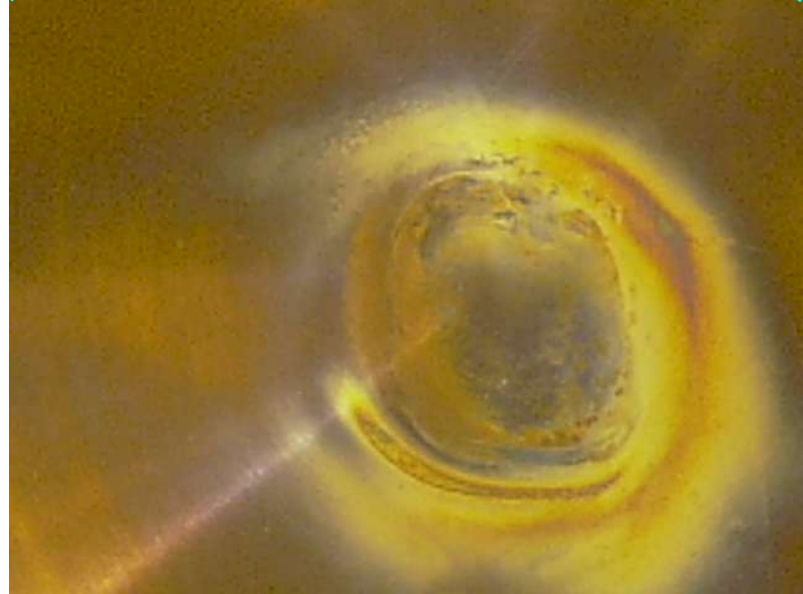
The beam window is damaged.  
**It is correct to replace it this year!!**

We have to investigate what happens to this part.

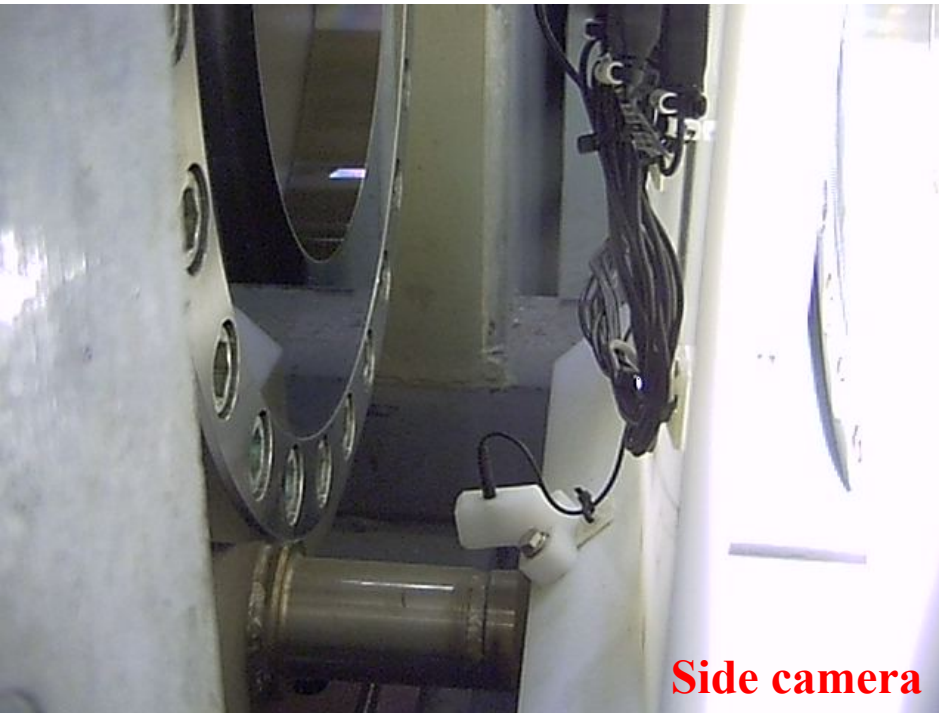
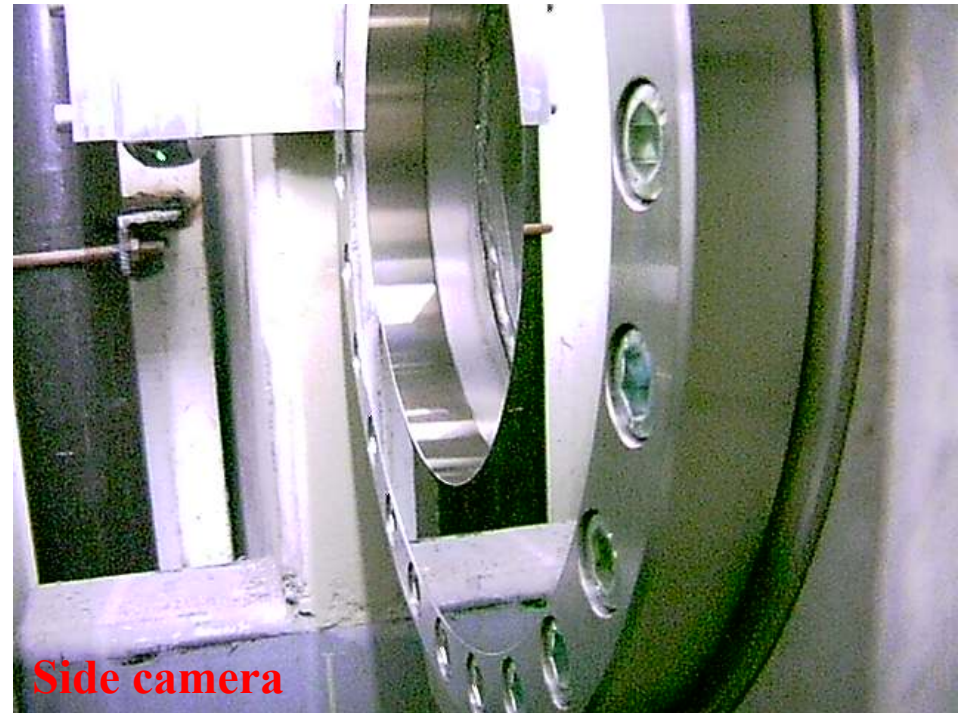
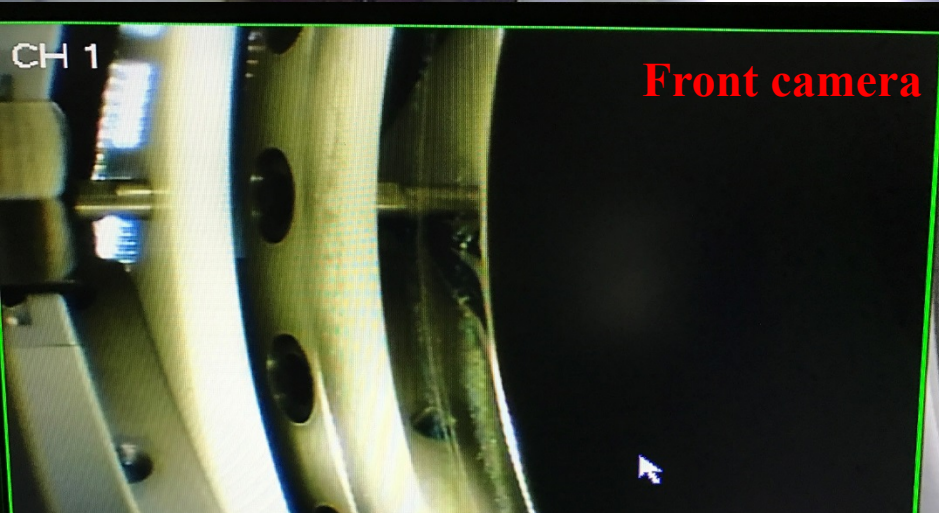
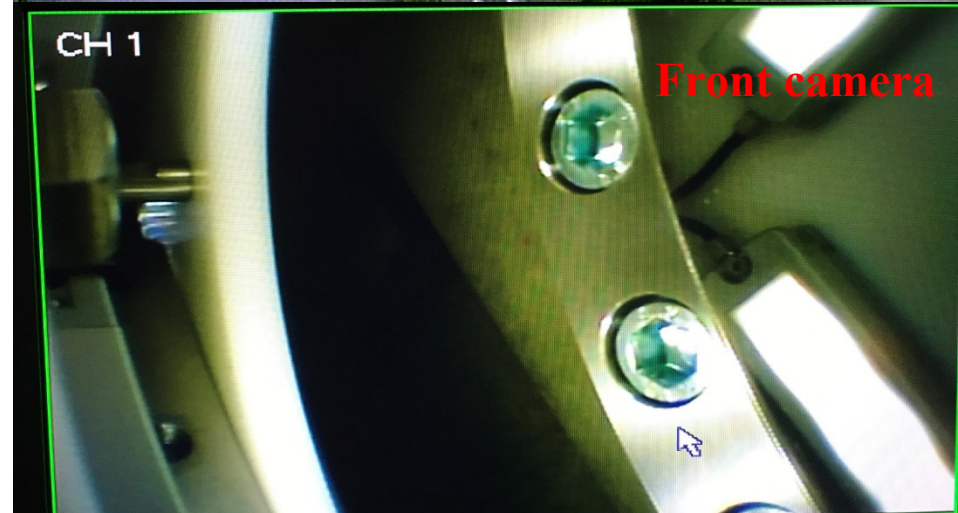
**Mirror flanges were very clean and had no scratch.**

**We skipped this process, because the mirror flanges are very clean.** he pillow seals

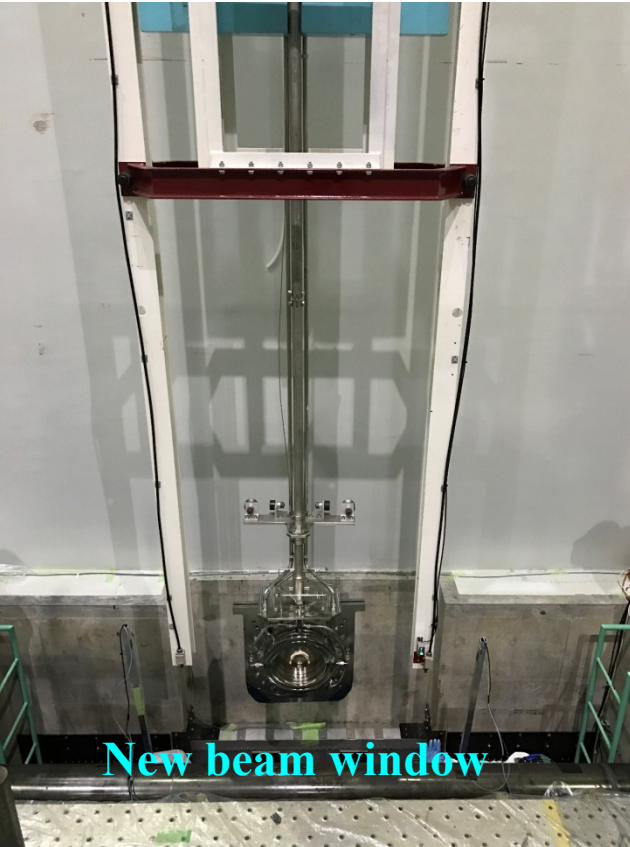
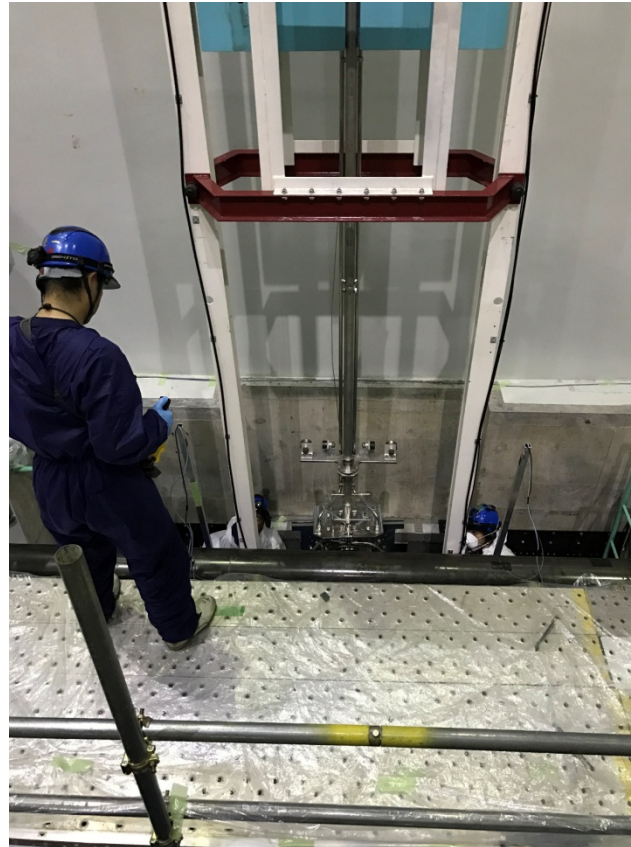
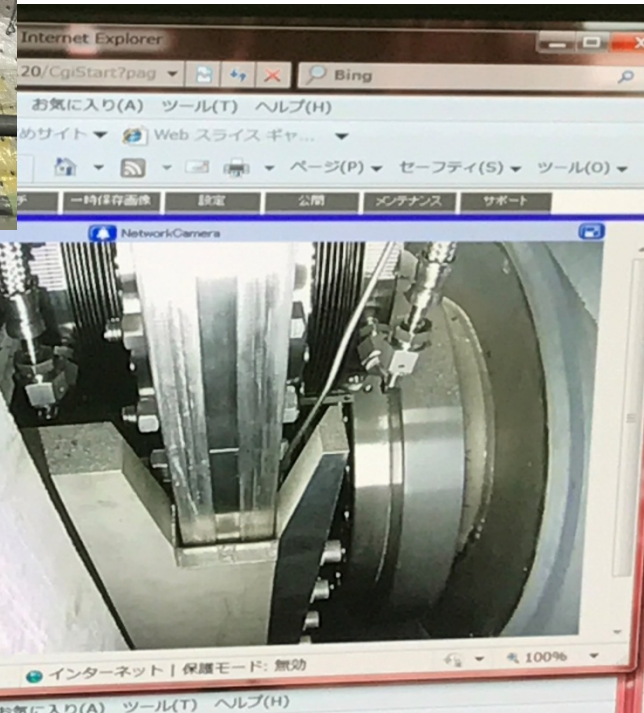
We can work near the beam window because the new one is not irradiated.

But it is necessary to watch the camera near the beam line.
