# **T2K Beam Window Replacement Work**

**2017.9.19  
KEK IPNS  
Tada**

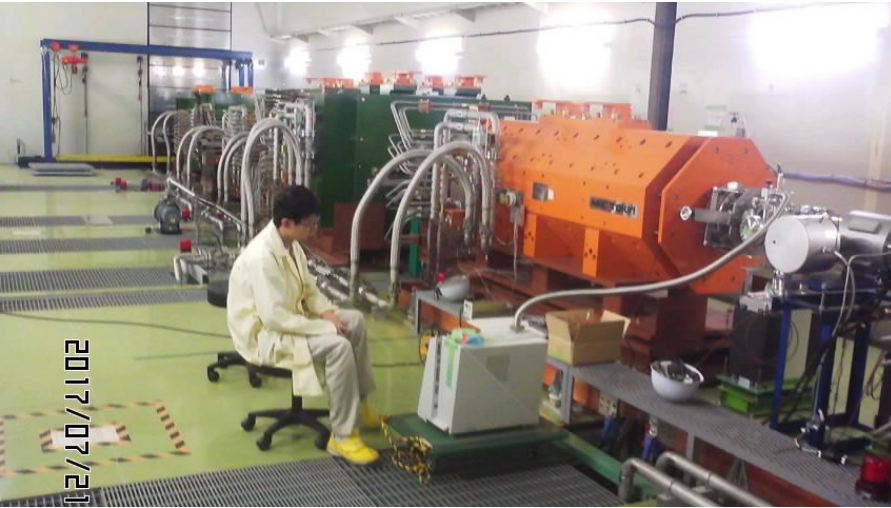
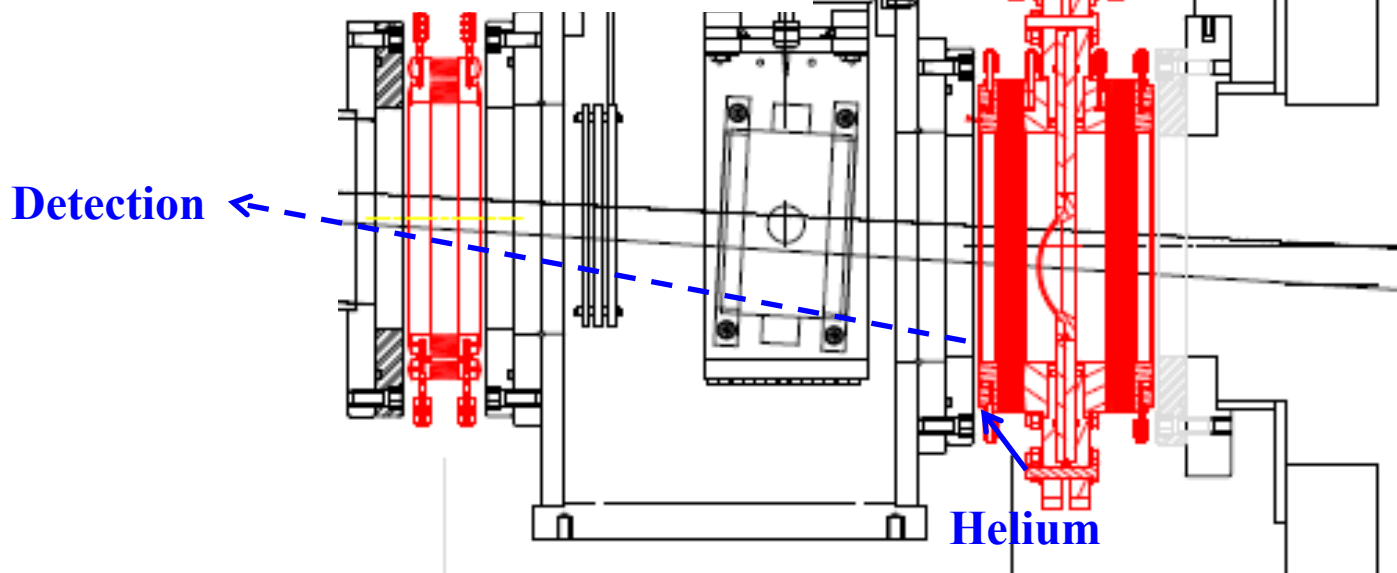
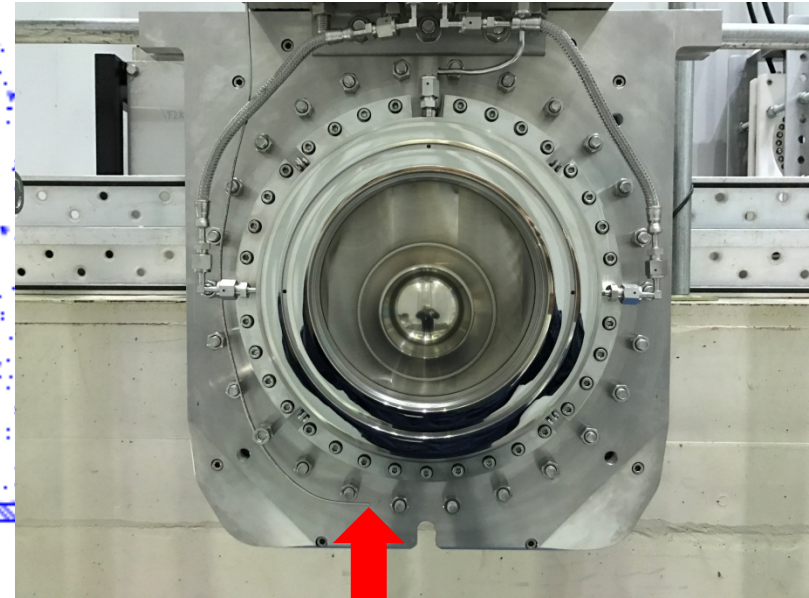
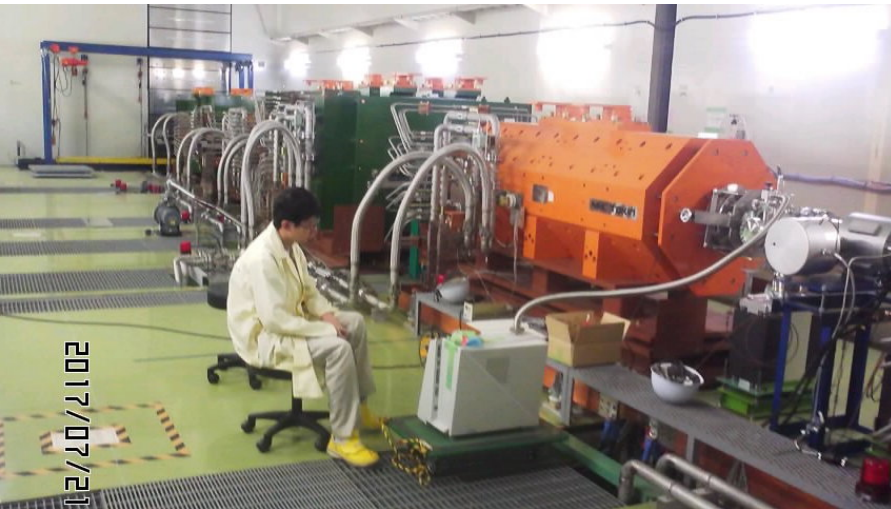
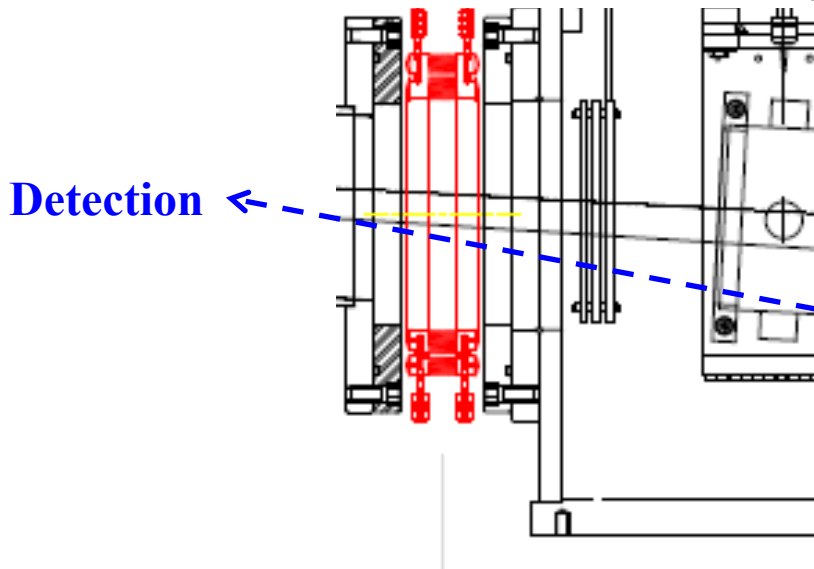
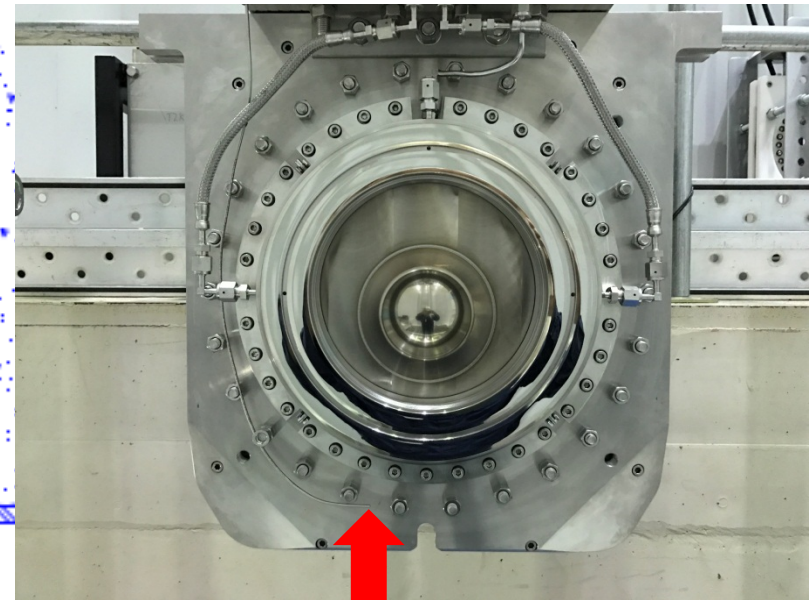
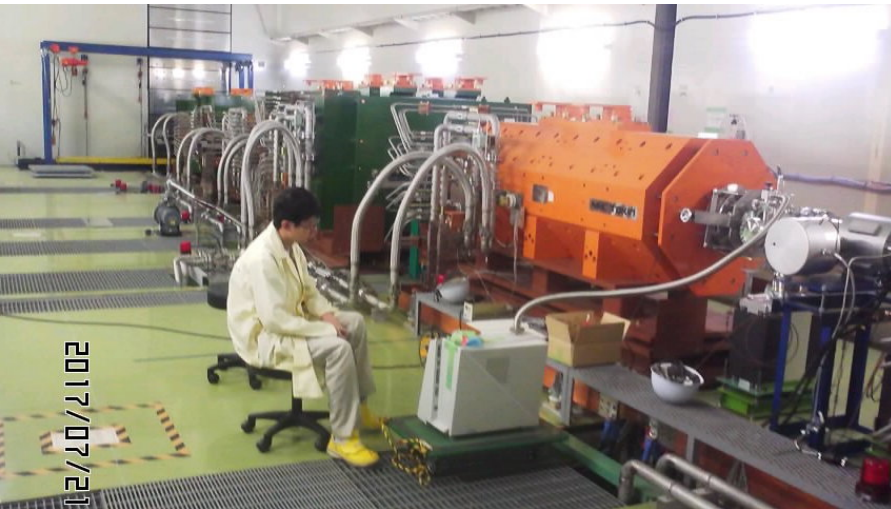
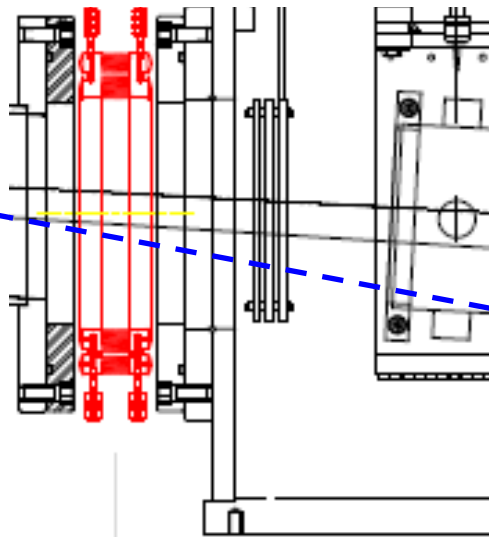
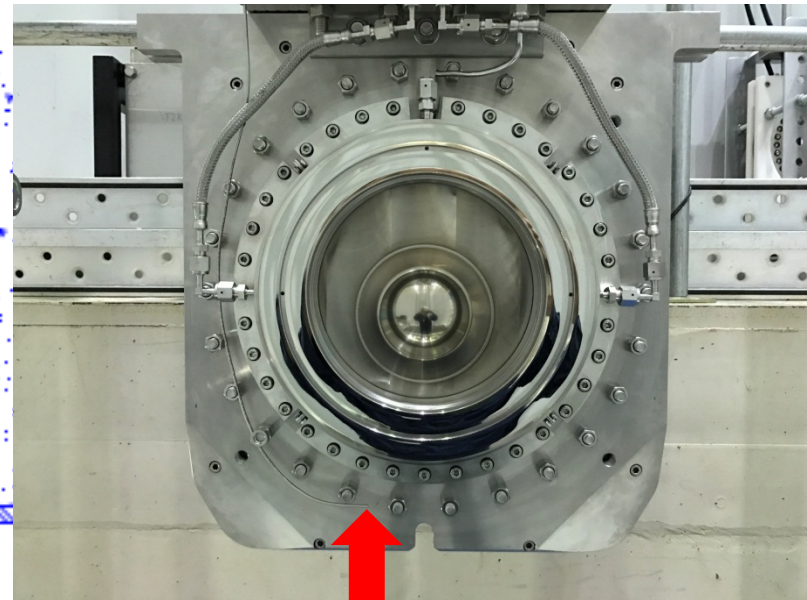
Helium gas was sprayed through the pipe for the leak test and the leak rate was detected with a helium leak detector in the primary beam line.

**Helium pipe  
for leak test**

**Before replacement ( old window )**

**$1.8 \times 10^{-9} \text{ Pa m}^3 / \text{sec}$**

**After replacement ( new window )**

**$1.4 \times 10^{-9} \text{ Pa m}^3 / \text{sec}$**

**Replacement work was succeeded!!**

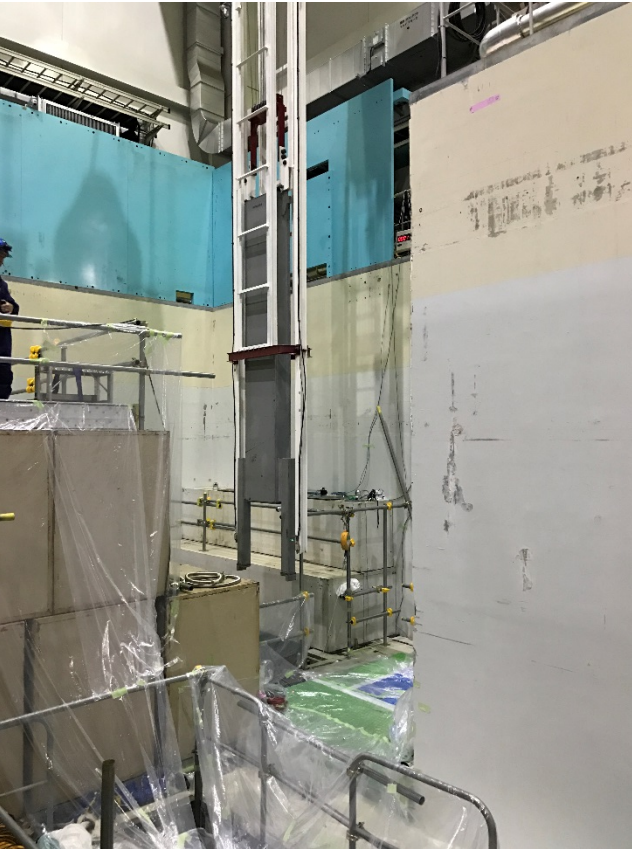
**Install the shield above the beam window**

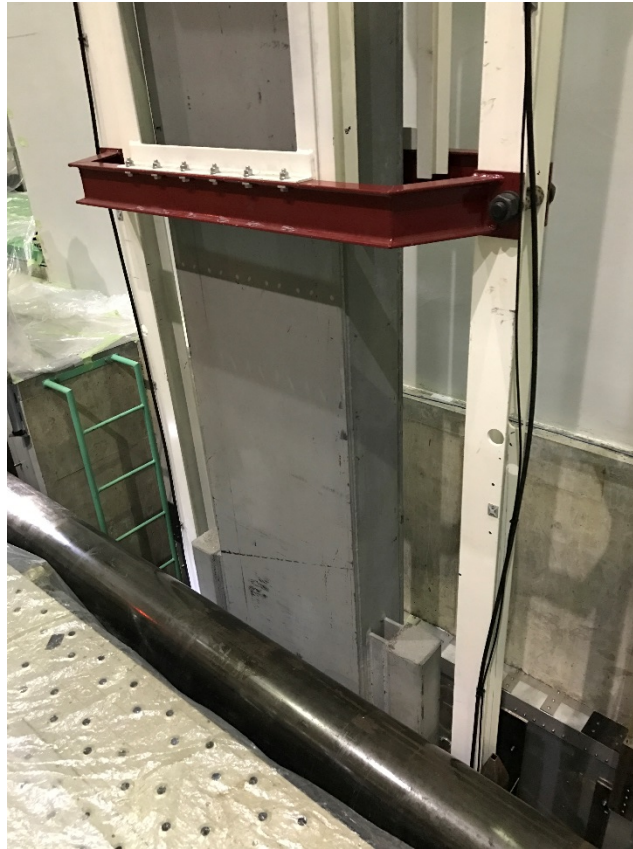
**Connect pipes**
