Design, Material Selection and Operational Feedback for the New Design of the High Energy Beam Dump in the CERN SPS

P. Rios-Rodriguez, A. Perillo-Marcone
M. Calviani (CERN)

- Introduction of the SPS beam dump (TIDVG)
- Previous SPS beam dumps
 - Design of TIDVG#3 (2014-2016)
 - Post-mortem inspection of TIDVG#3 (July 2017)
 - History of the SPS beam dumps
- Current SPS beam dump - TIDVG#4
 - Design
 - Material selection
 - Assembly and installation
 - Operational feedback for TIDVG#4
- Future SPS beam dump (TIDVG#5)
 - Design
 - Prototyping activities
- Conclusions

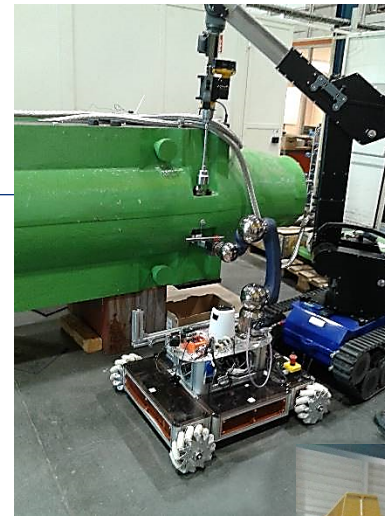
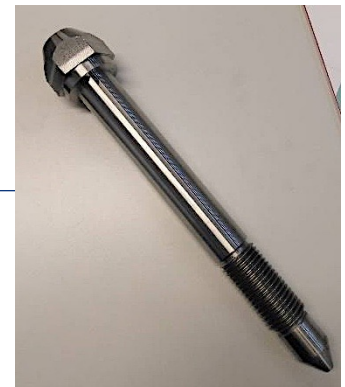
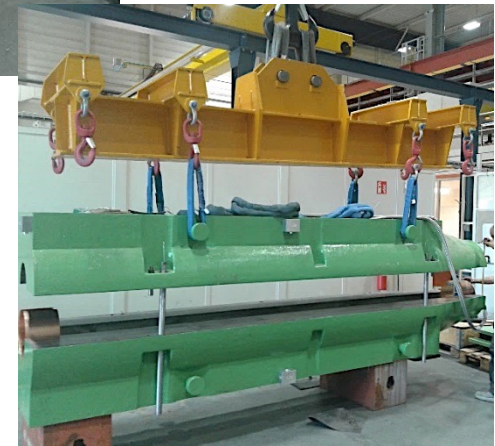
Preparation

- CATIA sequence to check feasibility and organize with teams
- Prepare work dose planning (consider recovery from problems)
- Mock-up trials on identical shielding to develop techniques for key tasks using mobile robots and crane:
 - Lifting mobile robots
 - Undoing shielding bolts (six M36 threaded bars with nuts)
 - Lifting upper shielding
 - Vacuum leak testing
 - Replacing shielding bolts

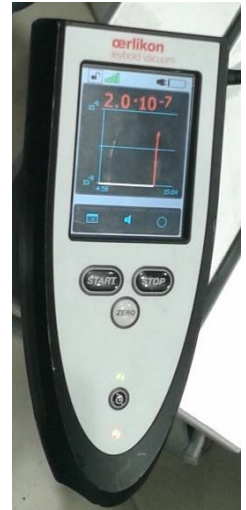
Inspection operation

- Operations went well
- Personnel radiation doses less than estimate (102 μSv vs 180 μSv)
- Leak testing was able to identify leak points
- Visual inspection showed weld condition
- Note: shielding opened 3x (1x in WDP)

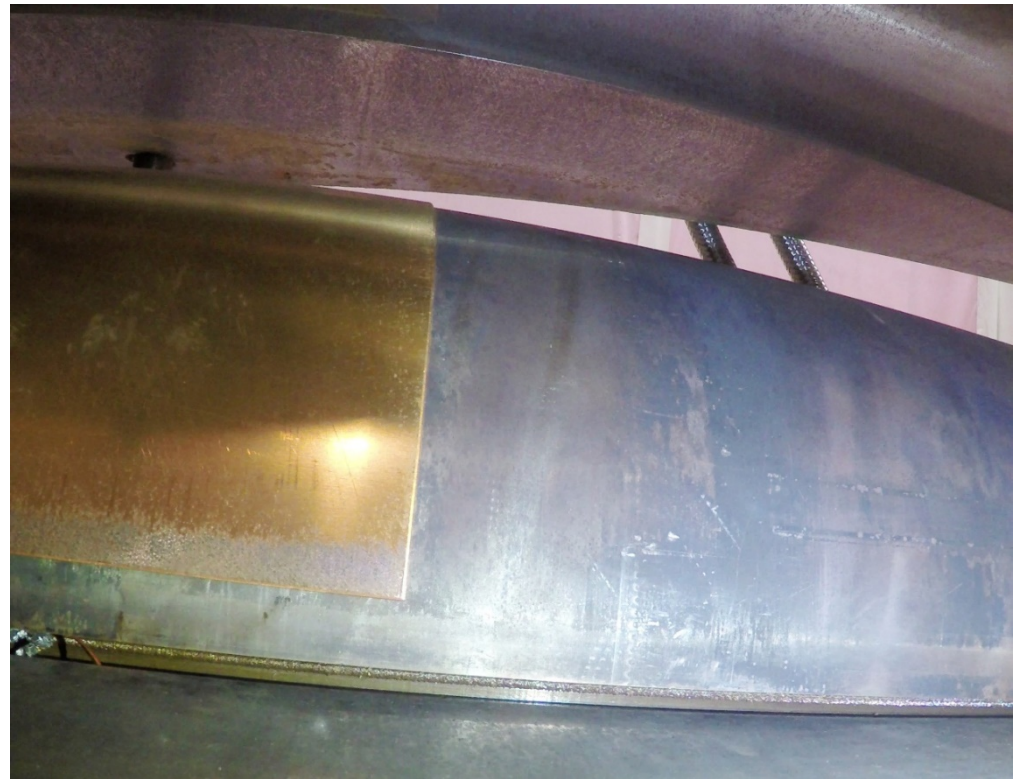
Findings

- Vacuum leaks were present on both longitudinal welds around half way the core
- The electron beam welds in the areas where leaks were found showed evidence of re-work
- Situation worsened by the fatigue (dump bending)

- Longitudinal electron beam welds along the core were identified as the source of the leak
- Positions of the leaks correspond to the areas of some of the weld re-work and the highest tensile stresses

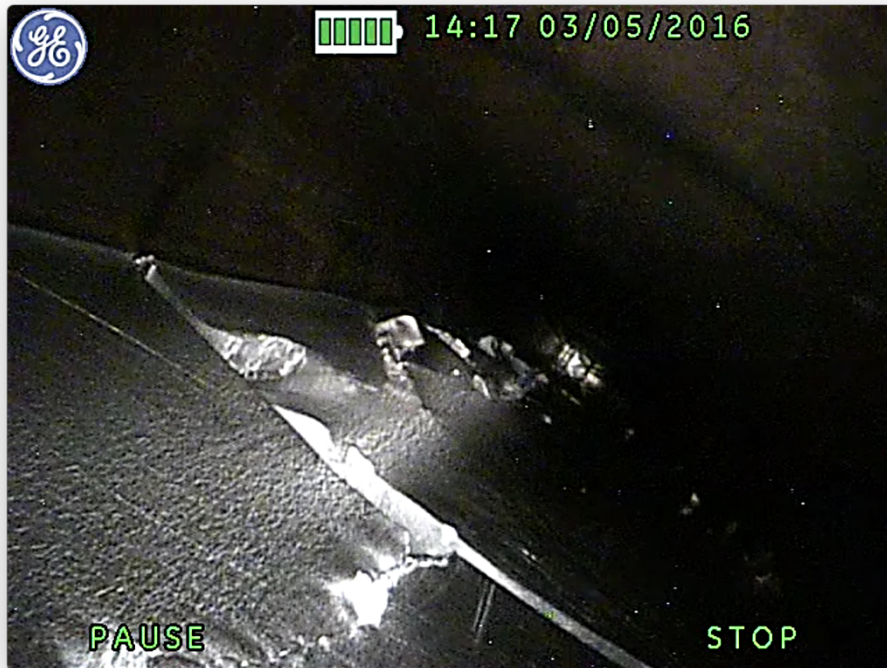
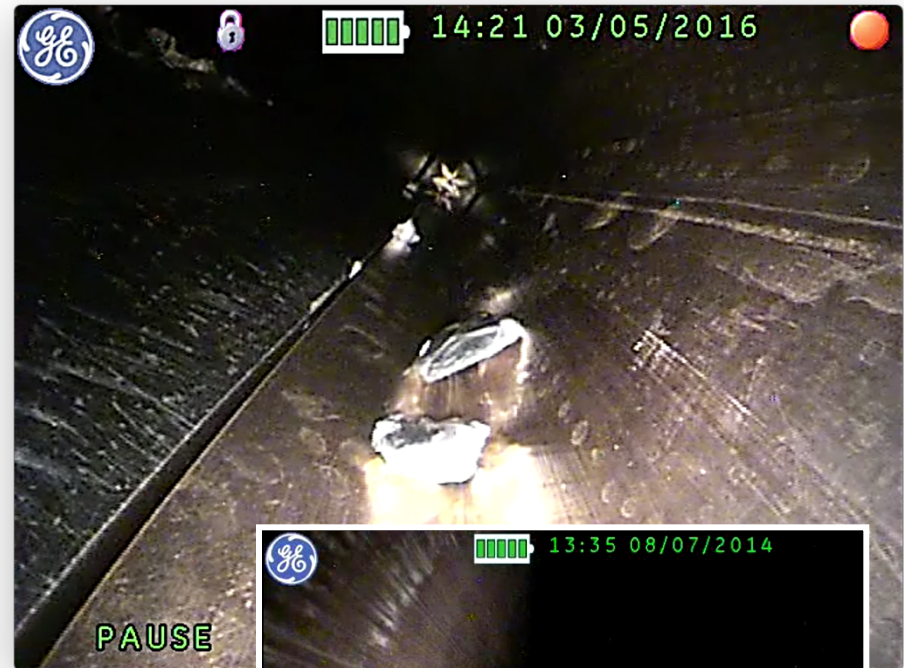
Ex. what happened to a previous TIDVG#2

- Molten Al due to beam impact
- Affected area much larger than beam size
- Culprit was the thermal contact conductance between Al and the heat sink

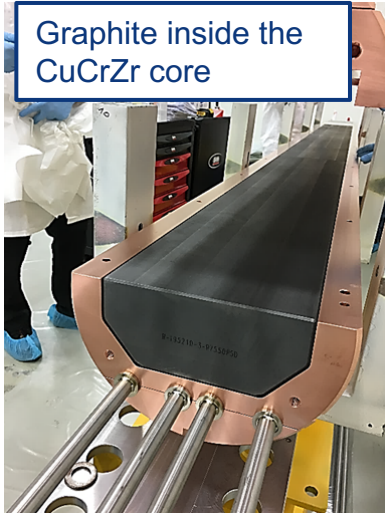
Graphite inside the
CuCrZr core

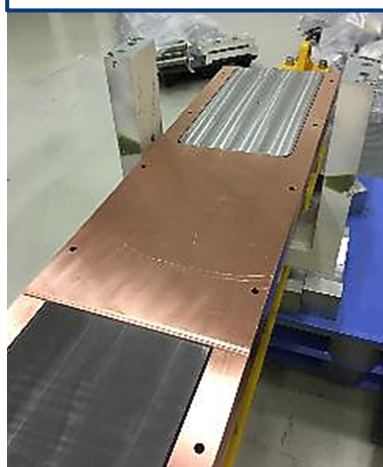
Medium/high-Z absorber

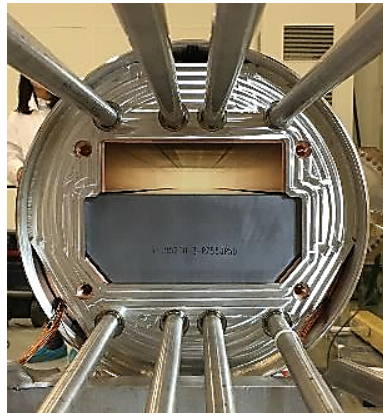
TIDVG#4 core fully
inserted (upstream)

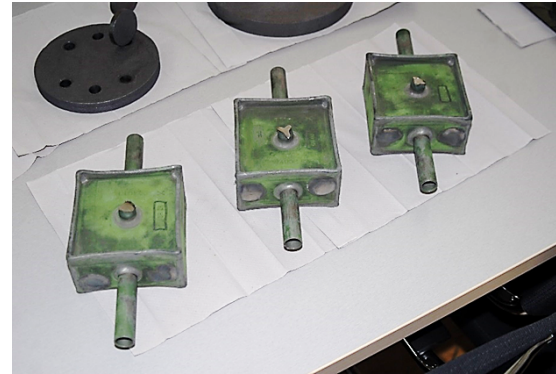
Future SPS beam dump: prototypes

HIP of cuprous materials around SS pipes (Fraunhofer): the contact between the tubes is made by diffusion bonding, i.e. perfect contact.
