# Status of the electrode material R&D for electrostatic septa at CERN

J. Borburgh, B. Balhan, L. Jorat, A. Prost

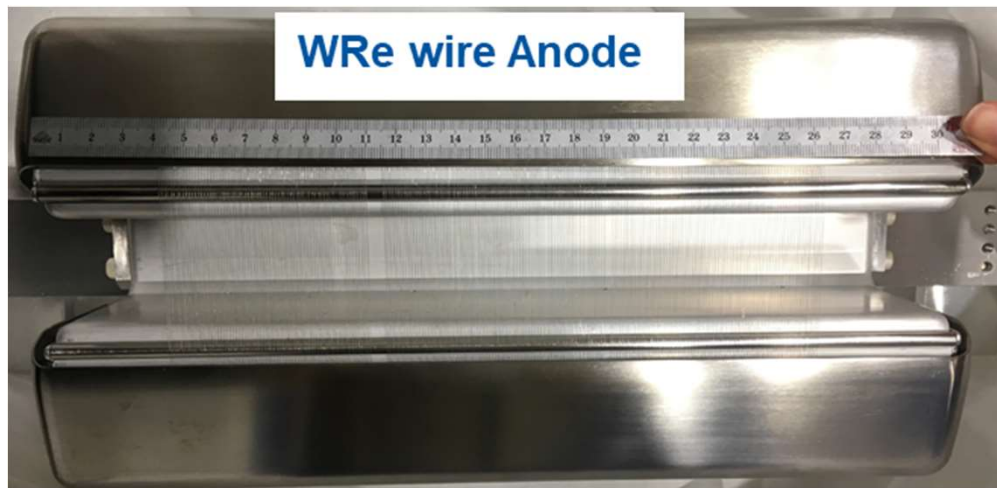
- Former LEAR septum is used as a test facility.
- Adjustable cathode gap (5 - 40 mm), nominal 10 mm.
- Septum anode wire 40 x 300 mm (V x H).
- Used existing test cathode.

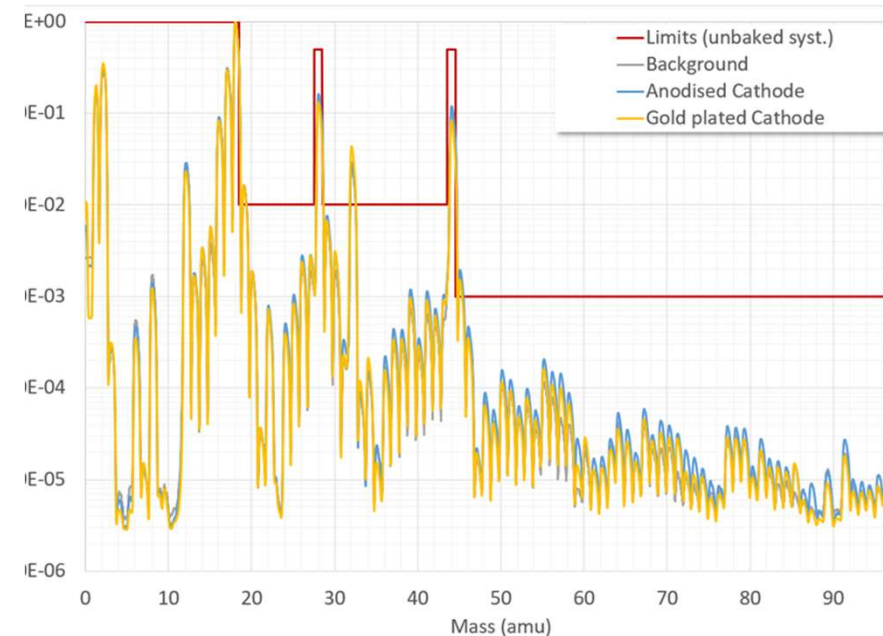
Outgassing of gold-plated Al alloy cathode much better than anodized variant.

Both cathodes residual gas analysis are compatible with CERN acceptance limits.
