Development and operation experience of collimators at SuperKEKB

Mini-workshop on impedance modeling and impedance effects at
SuperKEKB and future colliders, KEK, Dec. 15, 2022,

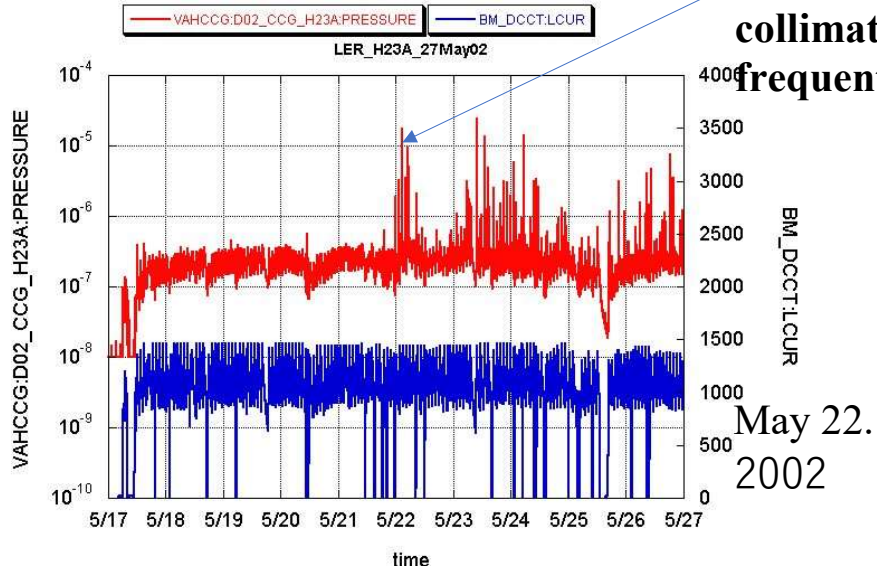
Pressure bursts (CCG near collimator) began to occur frequently on May 22.

The temperature of the bellows and collimator(LER V mask near IR) dropped as the collimator gap was widened. (Due to HOM.)

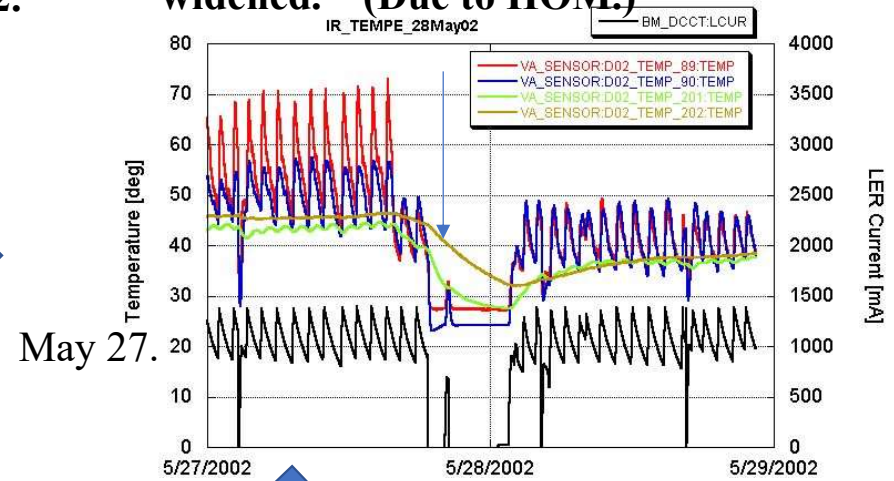
Heating of neighboring bellows

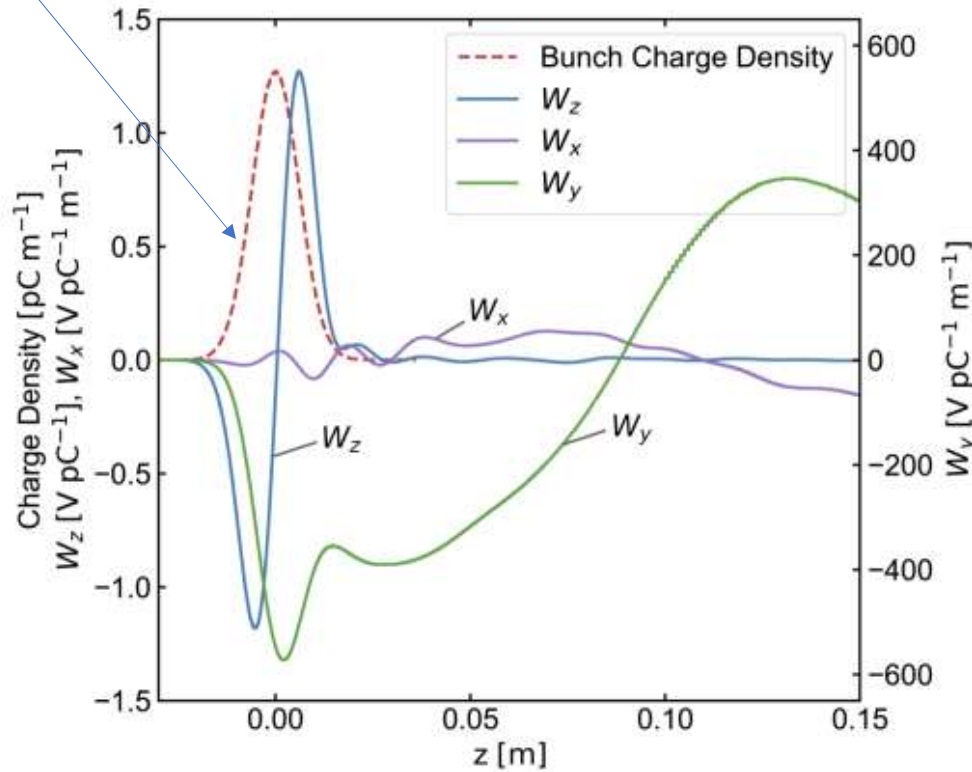
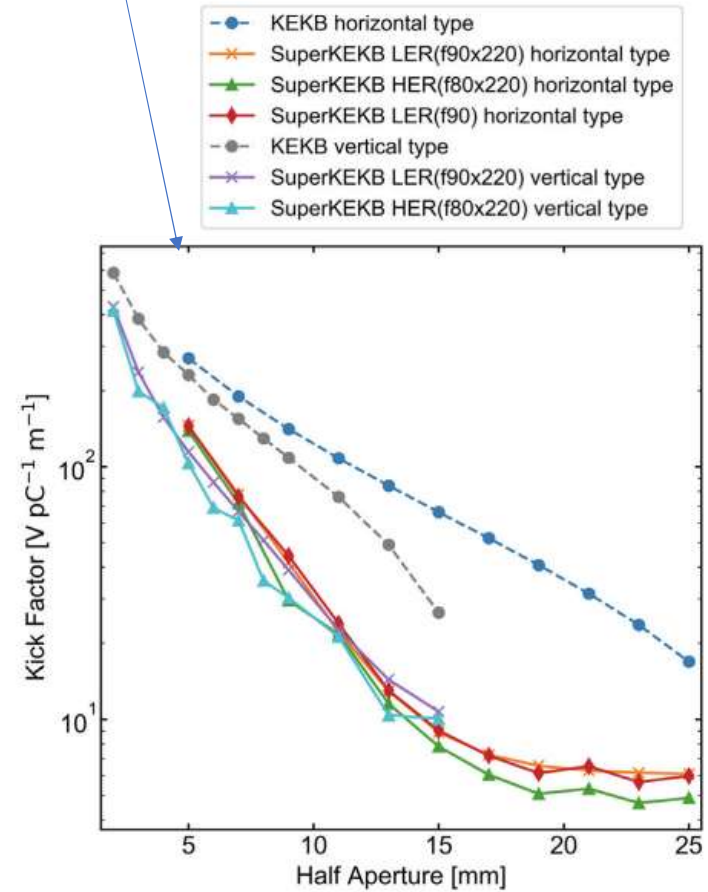
- Impedance calculations showed that the kick factor of the SuperKEKB-type collimator is smaller than that of the KEKB-type collimator.
- Large trapped modes were not seen.
- Wake calculations: Bunch length 6 mm using GDFIDL

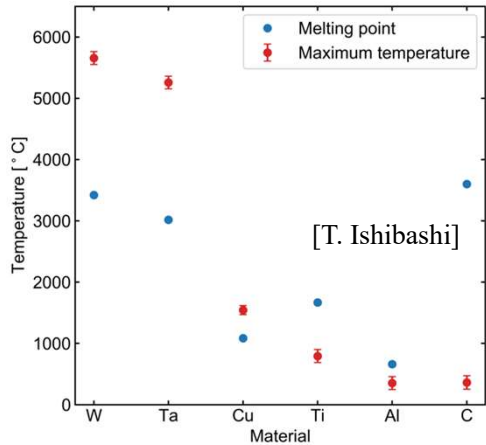
- In principle, any material should melt if the whole beam (LER design beam current 3.6 A) hits the jaw.
- Tungsten (W) was used for the tip material at first, but it was found that if it is damaged by the beam hit, it will become embrittled and generate a lot of radioactive dust.
- Tantalum (Ta) has been used as the default material of the tips.
- A special type of jaws named low-Z/carbon made from carbon fiber reinforced carbon (CFC) was developed for a more robust collimator, but the impedance problem arose and was given up (the radiation length of the carbon is long (~19.32 cm) compared with W/Ta (~0.35 cm/0.41 cm), so we need longer jaw to suppress the background).
- Hybrid jaws made from CFC and Ta were developed to improve the robustness of collimators. These jaws have been used without being damaged so far.

Maximum temperatures within 1 RL and melting points for each material, induced by the positron beam. The beam profile and energy are respectively Gaussian and 4 GeV. $Dx=y$ and the injected current are 0.5 mm and 50 mA (3.12×10^{12} positrons), respectively.

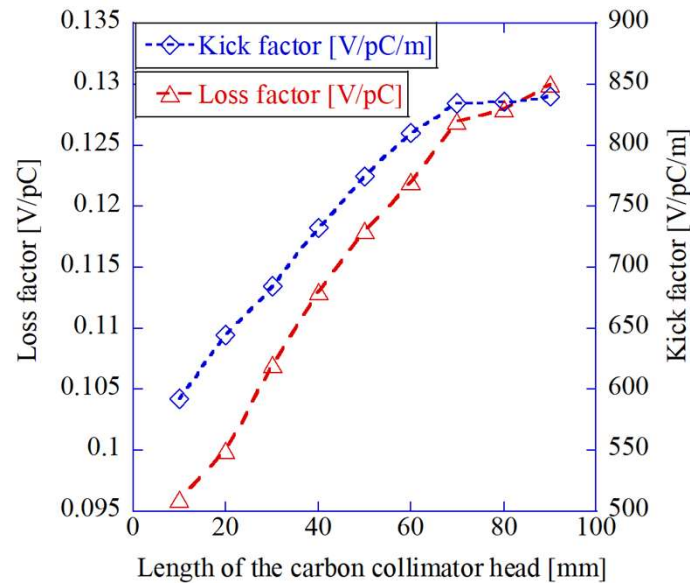
Impedance increases with longer head length.
Half gap 2mm, bunch length 6 mm

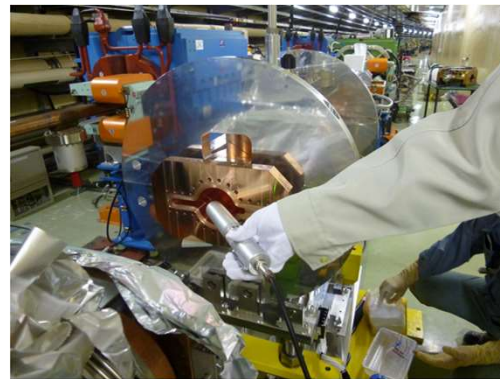
- (a) Before replacing the collimator jaws, measure the dose.
- (b) Rotate the collimator chamber to replace the vertical collimator jaws.
- (c) Remove the collimator jaws from the chamber.

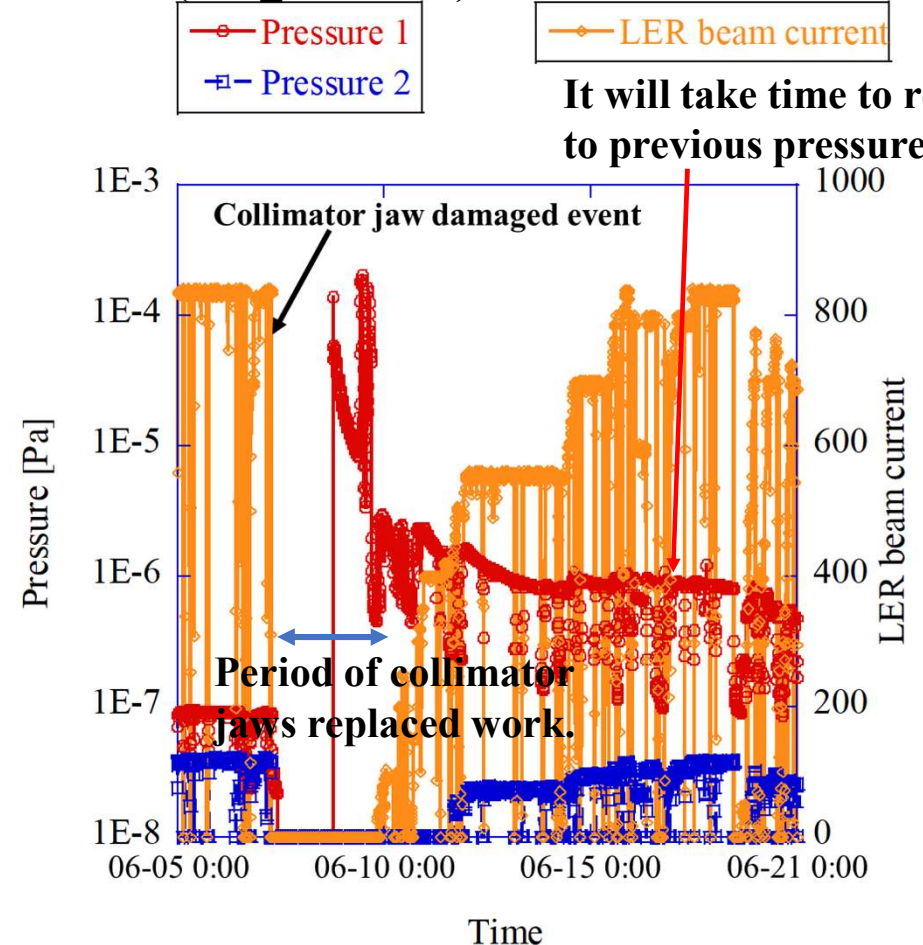
Pressure 1 (D02 L18 CCG): near D02V1 collimator

It will take time to return to previous pressure.

Replacement work of damaged jaws requires extra beam scrubbing to recover the vacuum pressure.

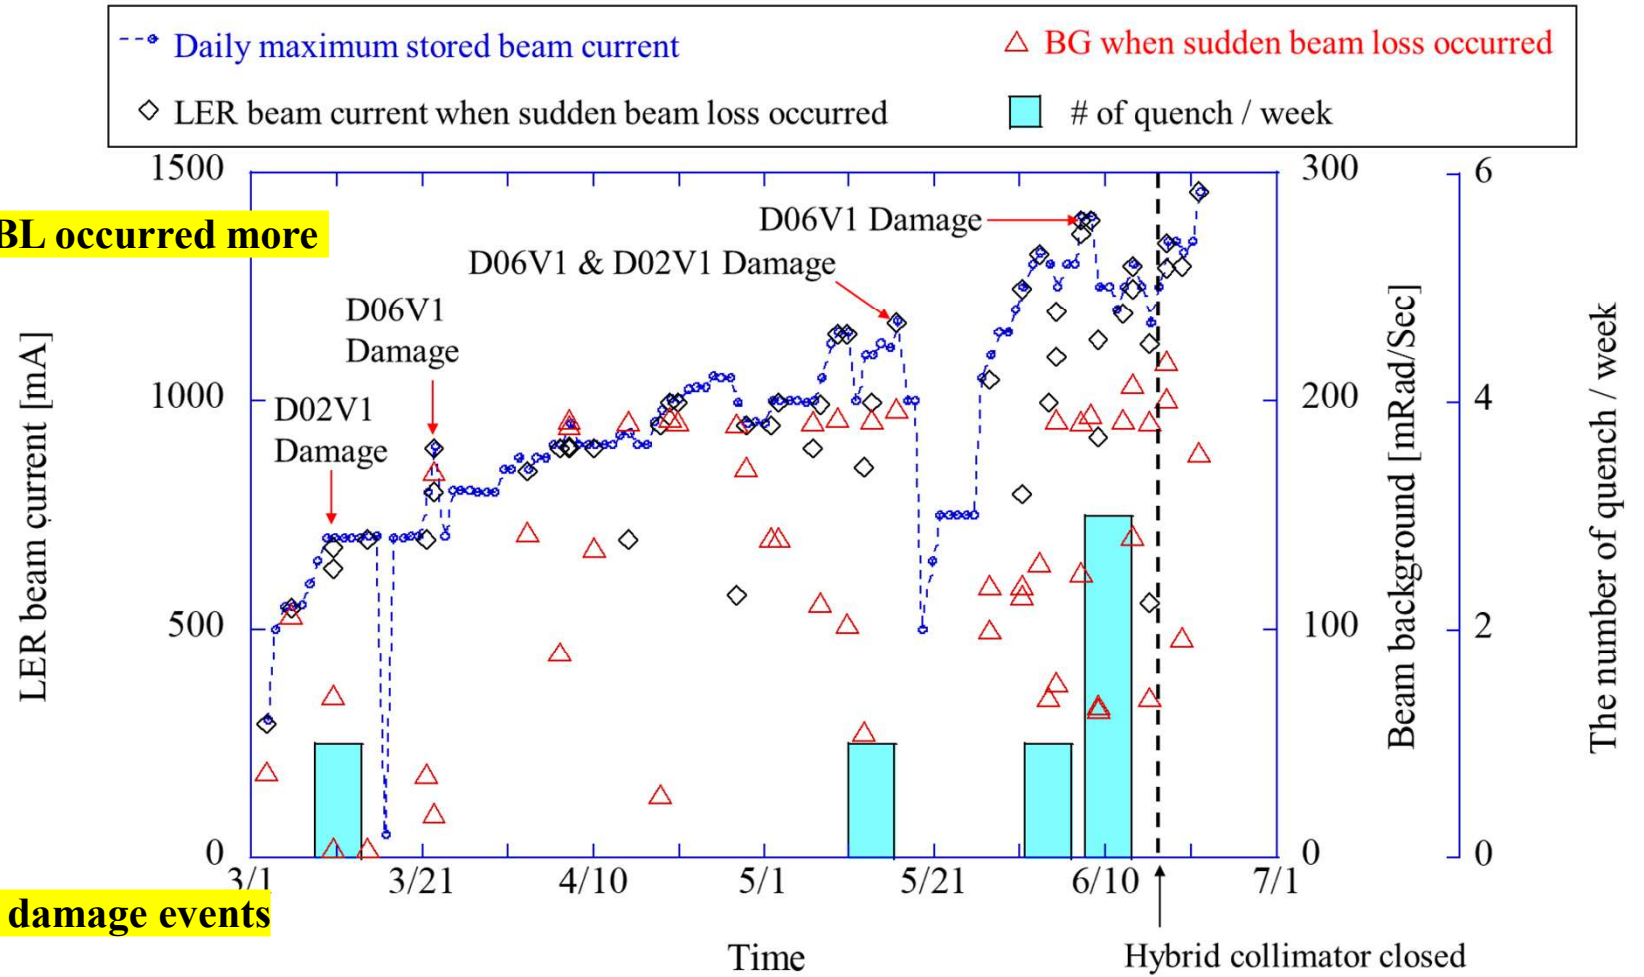
Sudden beam losses (SBLs) occasionally caused severe damages to collimator jaws.

During the 2022ab run, SBL occurred more than 40 times.

There were four collimator damage events during the 2022ab run.
