BRIDGE 2025 at Yayoi auditorium,
University of Tokyo on October 20, 2025.

MLF Muon target

KEK/J-PARC
Hikaru Sunagawa

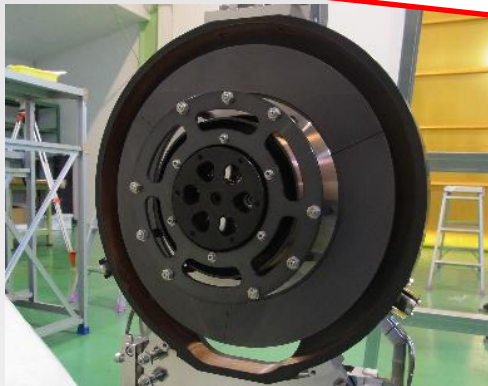
Muon rotating target (2014~)

Rotating target, installed in 2014
Lifetime: **Bearings**
Aiming Lifetime: 10 years at 1 MW operation

1st target : 2014-2019 (Design mistake of shaft coupling)
2nd target : 2019~

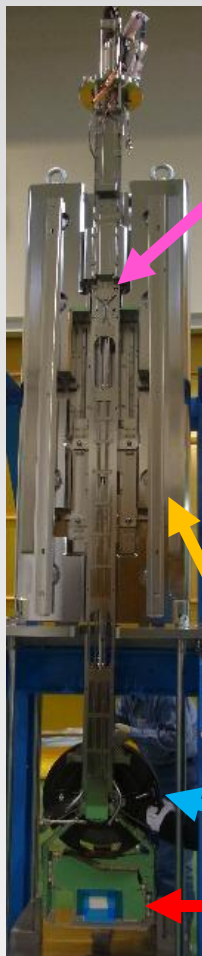
Muon production rotating target

Target rod:
Up and down
movement allows
monitors and targets
to be installed along
the proton beam line.

Plug shield:
Shield radiation
upward from the target,
enabling component
replacement above the
target.

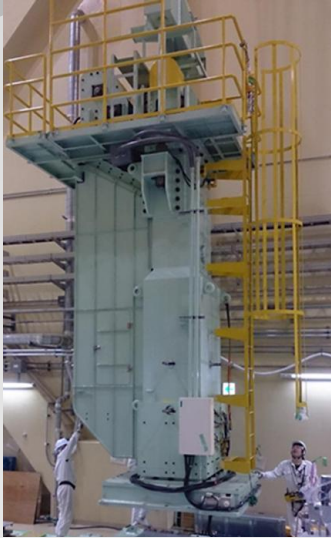
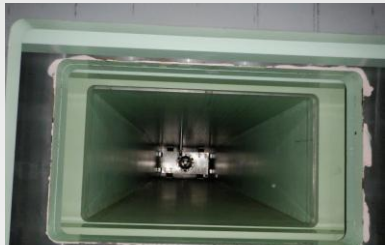
Remote controlled target replacement.

• Over view of the cask

• view from below

**Replacement of target
in 2019 was successful !**

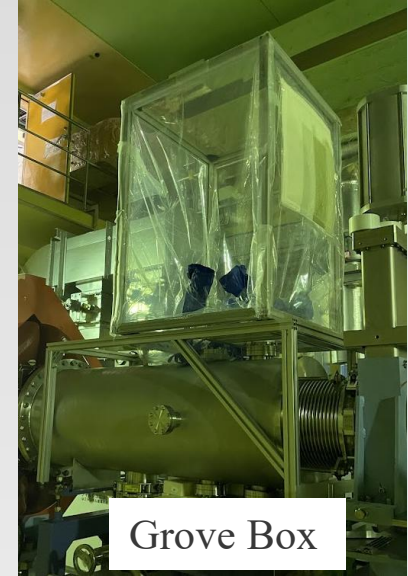
Beam profile monitor

○Photography from upstream of the beamline

Insert port (ICF114)
of camera

~12 m to the target

○Camera insertion jig
Adjustable for up/down,
rotation, and angle.

○Grove Box
Isolation of tritium diffusing
when the beam duct port is open

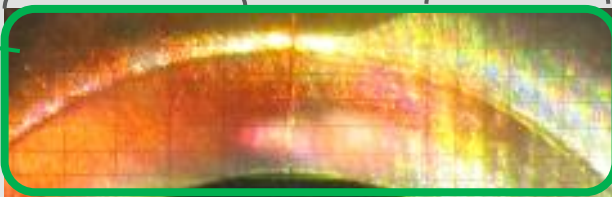
Several wires **towards the right of the center** are missing. (No.11-16)

The **slider** is down.

The wire has come loose from the top, It suggests a bias in the pattern of wire detachment.

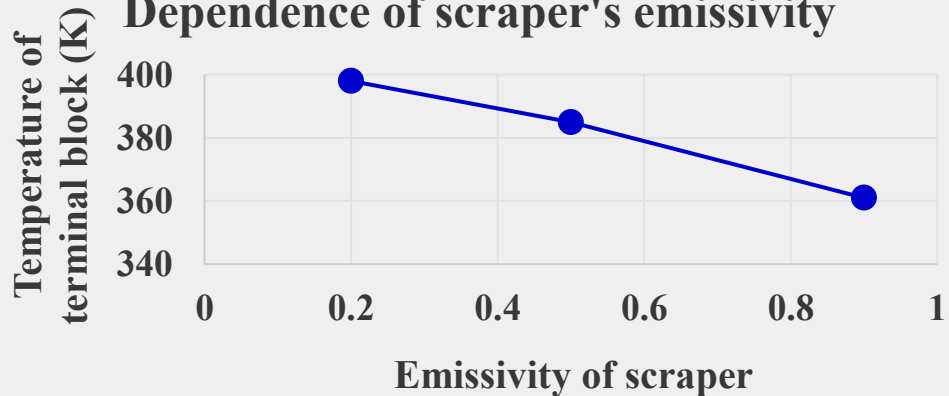
Dependence of scraper's emissivity

○The terminal block temperature is dependent on emissivity of scraper.
